**GEOTECHNICAL INVESTIGATION
JANITELL BRIDGE
FOUNTAIN CREEK
EL PASO COUNTY, COLORADO**

**Alfred Benesch & Company
7979 E. Tufts Avenue, Suite 800
Denver, Colorado 80237**

CTL|T Project No. CS19402-125

September 28, 2021

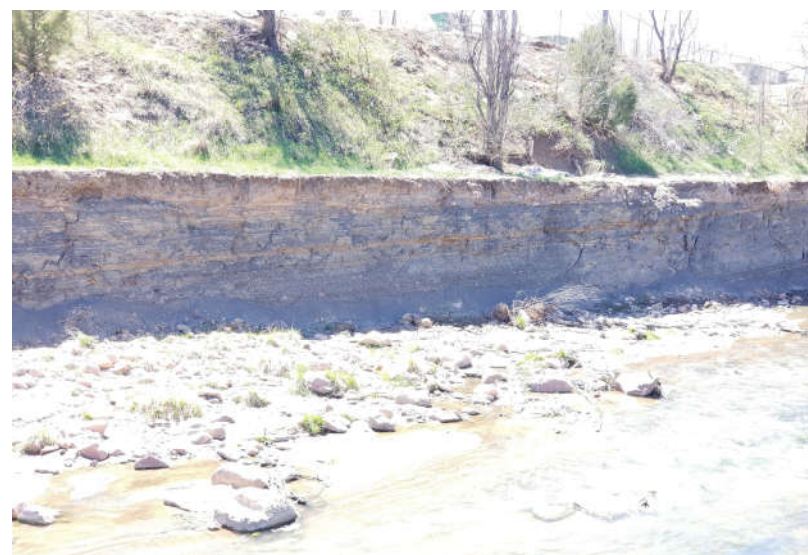
We understand scour remediation measures will likely consist of a drop structure downstream of the bridge and/or a cutoff wall extending around the south side of pier P-5. Based on observations of the north bank, there has been erosion into the shale bedrock. As such, a smooth/linear change in the bedrock surface is not expected between TH-3 and TH-4. Bedrock elevations along pier P-5 are estimated to range from about 5825 to 5826, while the bedrock surface along the north bank ranges from about 5829 to 5830. This change in elevation from the pier to the bank occurs abruptly.

4. Erosion of the shale bedrock northwest of the bridge, near Spring Creek.

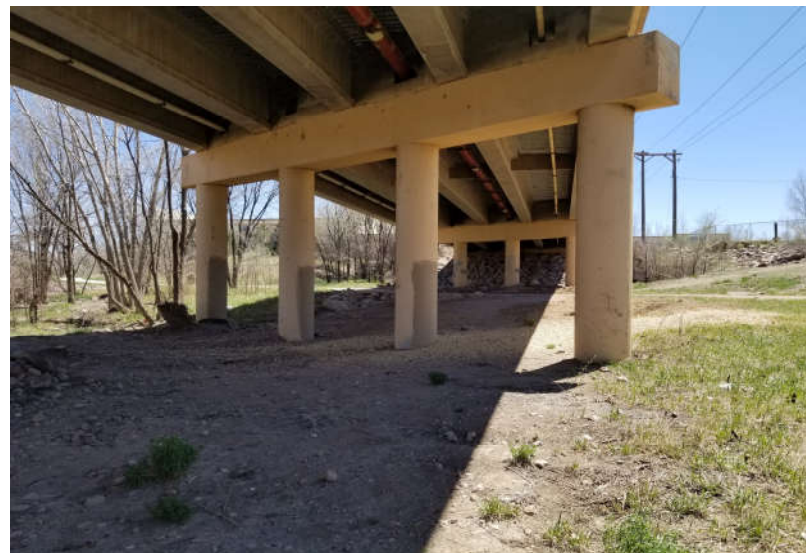
The surficial deposits are part of the alluvial terrace deposits or fills likely derived from the same. The soils are subject to erosion and deposition based on flows in the creek. A relatively flat sand/gravel bar has been forming on the south side of the creek, at the bridge location, and extends to just north of bridge pier P-4. The sands and gravels are generally not present in the main creek channel.

6. Gravel/sand bar, trail, and south abutment.

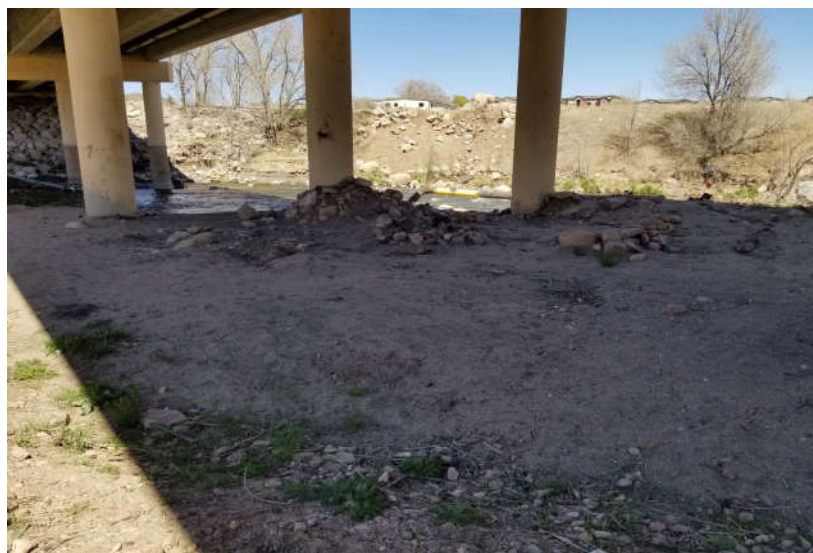
7. Gravel/sand bar looking north towards pier P-4 and P-5.

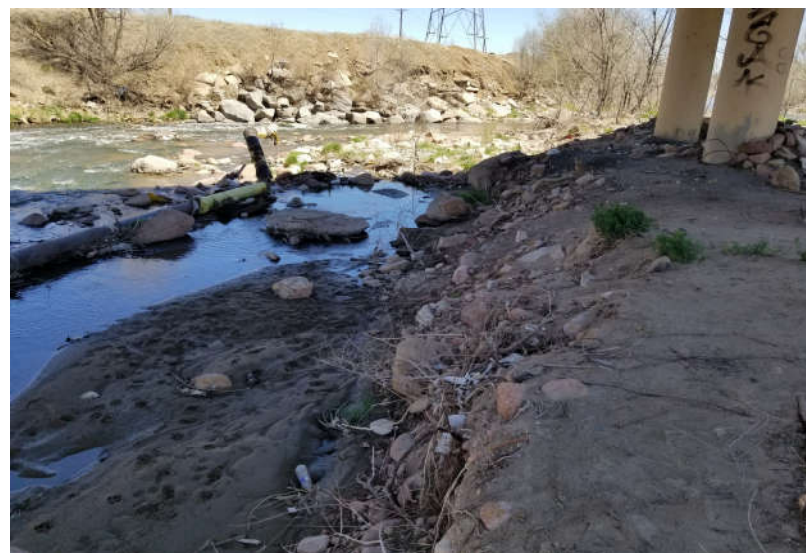
8. Gravel/sand bar at edge of creek at pier P-4.

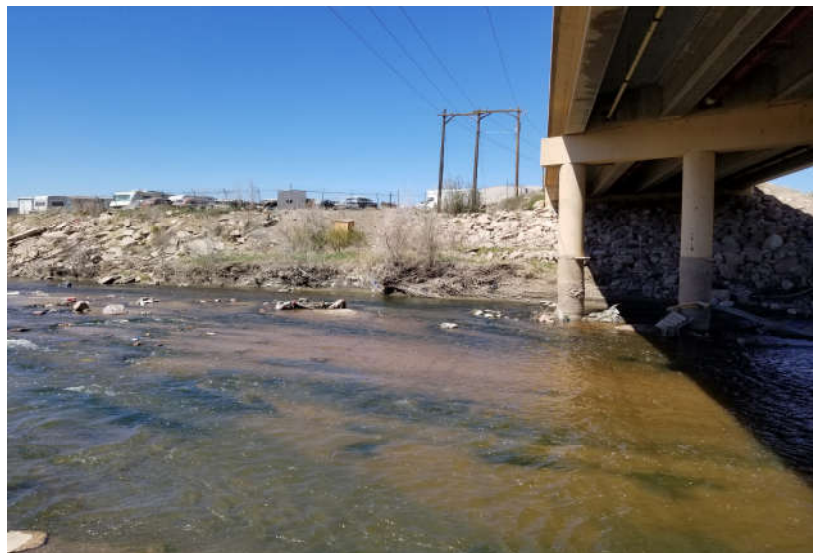
9. West side of pier P-5.

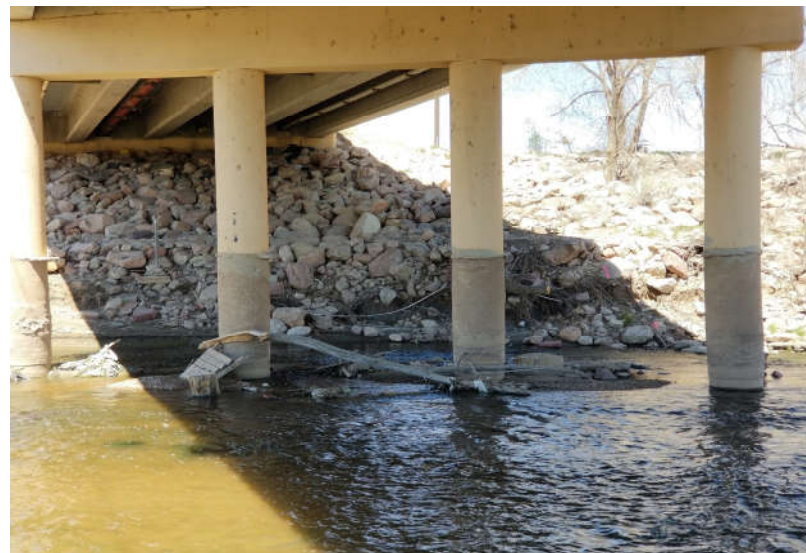
10. Pier P-5 looking north.

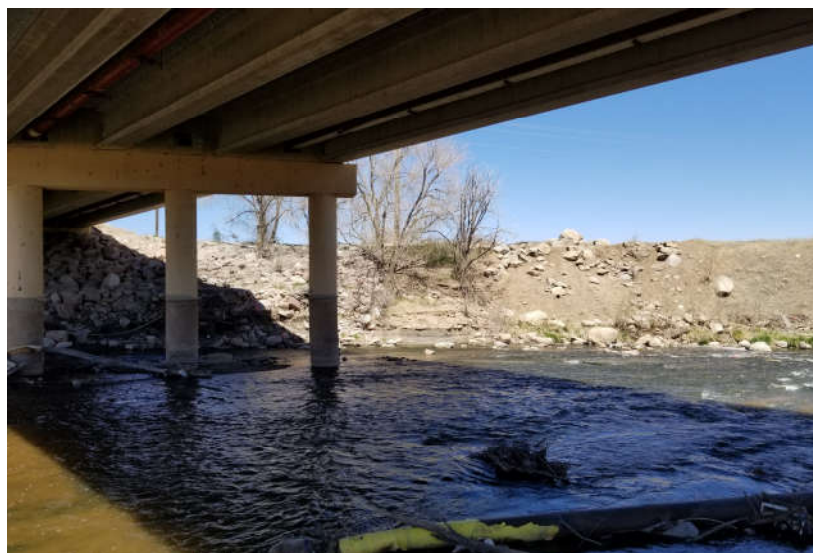
11. East side of pier P-5.

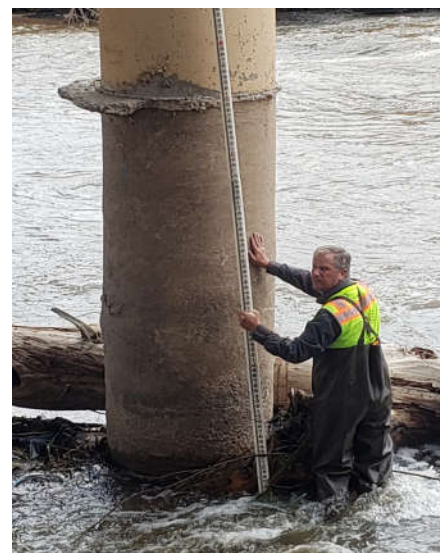
12. Measurement of western pier at P-5; approximately 9 feet below previous ground elevation.

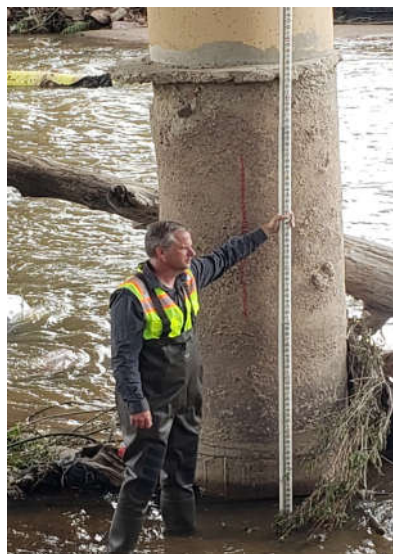
13. Measurement of middle-western pier at P-5; approximately 8.5 feet below previous ground elevation.

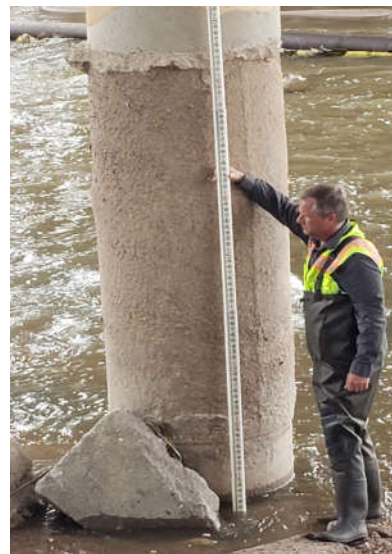
14. Measurement of middle-eastern pier at P-5; approximately 8.5 feet below previous ground elevation.

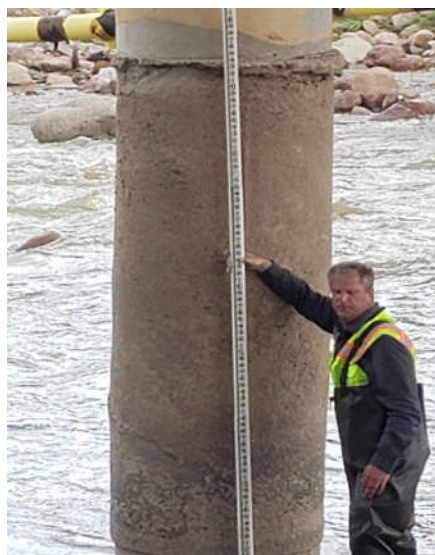
15. Measurement of eastern pier at P-5; approximately 9.3 feet below previous ground elevation.
