Janitell Bridge over Fountain Creek Scour Protection Project

Structure No. EPC 0377-00.50A

Final Drainage Report

December 2022

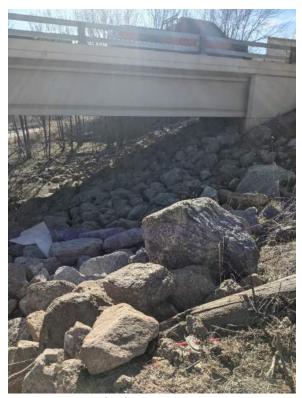
Upstream south abutment, intact riprap.

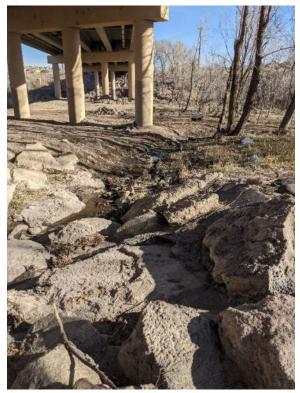
Pier 2, looking north downstream side.

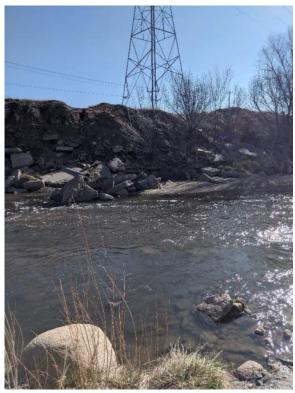
Downstream power tower, eroded bank.

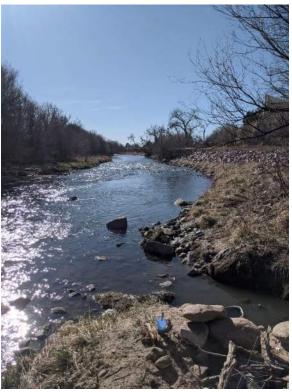
Looking downstream, trail rirap abutment.

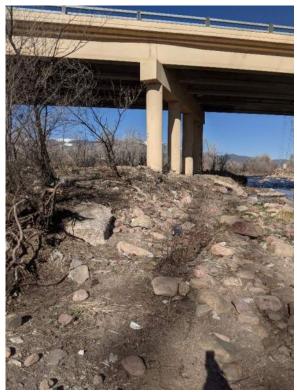
Looking upstream at Pier 4.

Riprap will be placed along the north abutment and at the bridge at Piers 3 and 4, outside of the channel. Seeding, soil conditioning, and coir mats will be placed along the new south channel to stabilize the excavated areas. Excavated channel material will be stockpiled to be placed in the new channel.

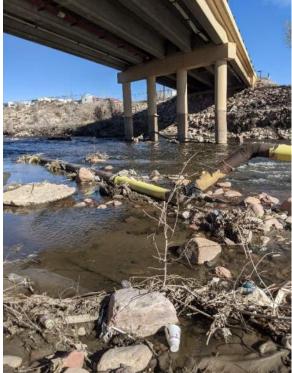
Looking upstream ar Pier 5.

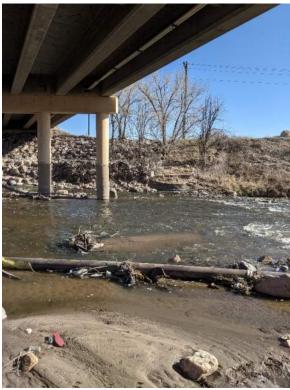
Pier 5 and north downstream bank.

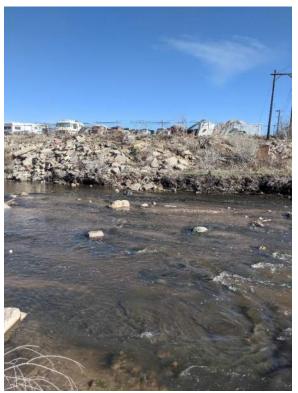
Upstream north bank rubble.

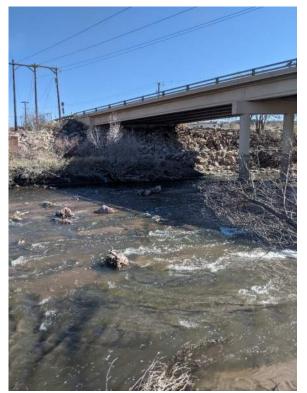
Upstream abutment 6 erosion.

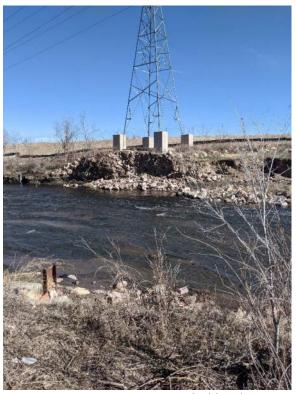
Upstream power tower, eroded bank.

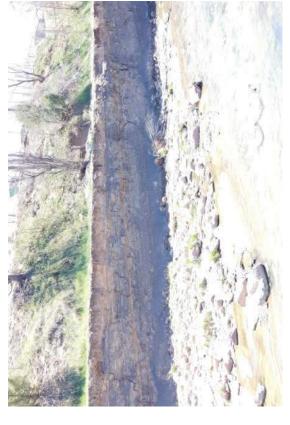
4. Erosion of the shale bedrock northwest of the bridge, near Spring Creek.

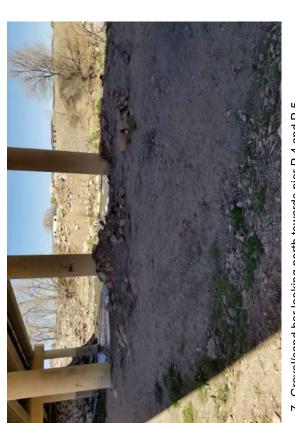
7. Gravel/sand bar looking north towards pier P-4 and P-5.

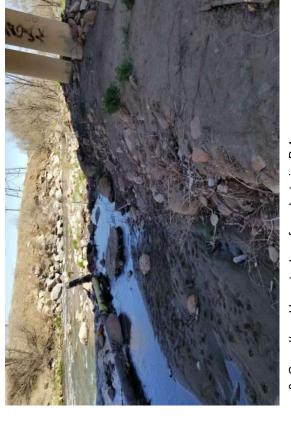
8. Gravel/sand bar at edge of creek at pier P-4.

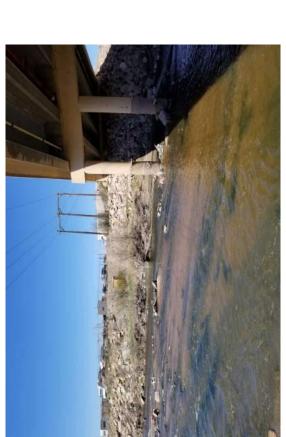
9. West side of pier P-5.

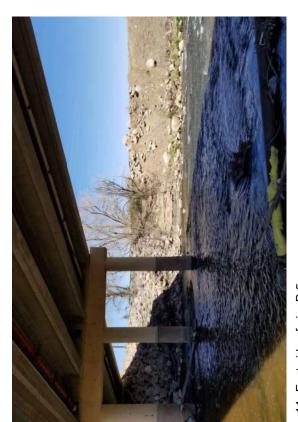
11. East side of pier P-5.

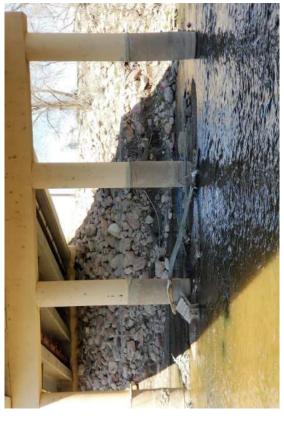
10. Pier P-5 looking north.

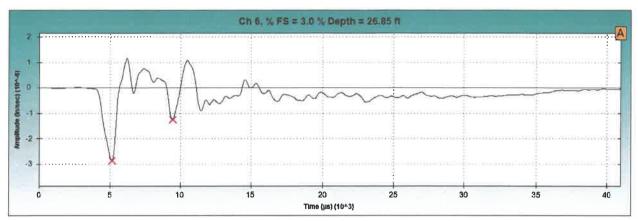
Figure 2: Sonic Echo (SE) data for the S Pier (File SEIR6) showing a bottom echo depth at 26.8 feet, with no significant echoes shallower than the bottom echo.

Figure 2 presents the SE results for the East foundation of Pier 3. The SE/IR results indicate Sound pier conditions for the South pier, with a strong, clear tip echo at 26.8 feet below the receiver. As noted in the results table, the receiver was located 0.8 ft above local grade, giving an embedded depth of 26.0 feet for this shaft. No notable shallow echoes that would indicate a concrete anomaly were observed in the data.
