RE: Paint Mines Interpretive Park Restoration (Con# 20-112) (HC# 78632)

Subject: HC# 78636 – Paint Mines Interpretive Park Restoration (Con# 20-112)

PAINT MINES INTERPRETIVE **PARK RESTORATION PROJECT**

Client Name: Smith Project: Paint Mines Interpretive Park Project No.: 2020-010

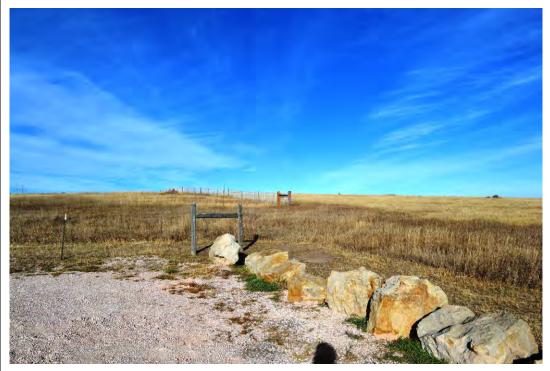
Turning to the archaeological deposits at PMIP and their relation to the geomorphology of the area and project impacts, in Photograph DSC_4389 of the upland areas, **Site 5EP.3094** is located to the left and right of the snow fence in the center ground. This site was mapped as extending to the east end of the snow fence and the area between it and the parking lot was intensively re-surveyed to confirm this. No materials were observed in this area. A portion of a stone circle originally mapped at the west end of the snow fence was observed to be well-sodded and stable. The site is situated in Bresser sandy loam over the White River formation bedrock, which supports a thick grass coverage and relatively stable surfaces subject to minor wind and water erosion. Typically, archaeological deposits in these settings tend to be surficial and do not yield materials below the level of the solum, which is borne out by the identification on the surface of this site of projectile point types from late Archaic or early Ceramic to the late Prehistoric stage. The proposed activity nearest to this site is this use of the south parking Lot as a staging area, which will not have any impacts to this site.

Looking west from the South Parking Lot at stable surface formed on caprock residuum. The eastern extent of site 5EP.3094 corresponds with the posts in the center at the end of the snow fence.

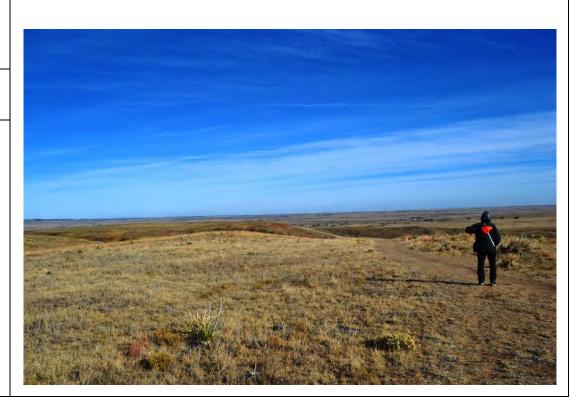
Gently sloping glide terrain east of the South Parking Lot looking northnortheast.

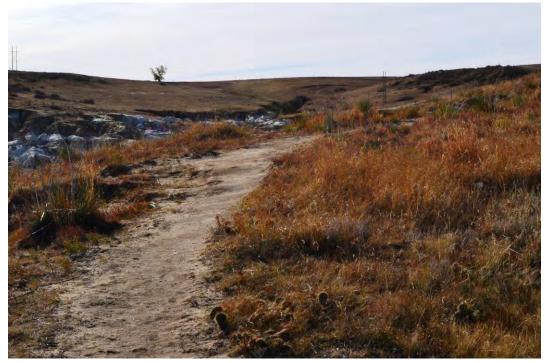
Background shows historic slumps and glides and an active slump at south end of main pediment area. Portion of site 5EP.3122 crossed by trail is in the foreground. Facing south.

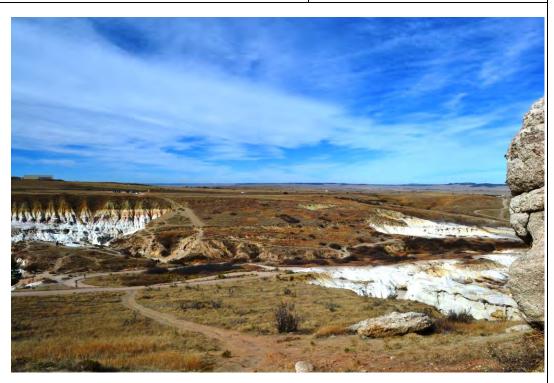
From east side of main arroyo looking west at large glide along west side with site 5EP.3121 at toe and site 5EP.3122 along top edge above and along breakaway line. A remnant of the White River formation caprock at far right foreground.

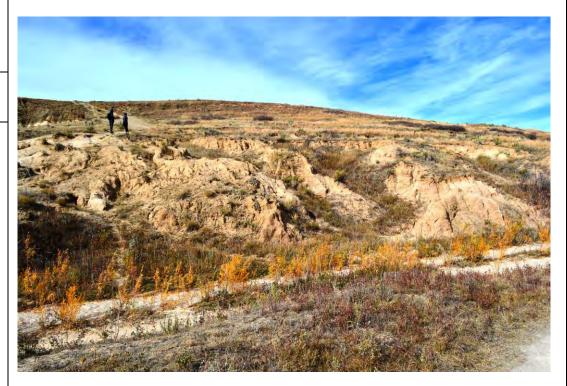
Looking west at toe of large glide along west side of main arroyo. Site 5EP.3122 is in these materials up to approximately where the figures are standing and extending to the right. Photograph was taken from the trail.

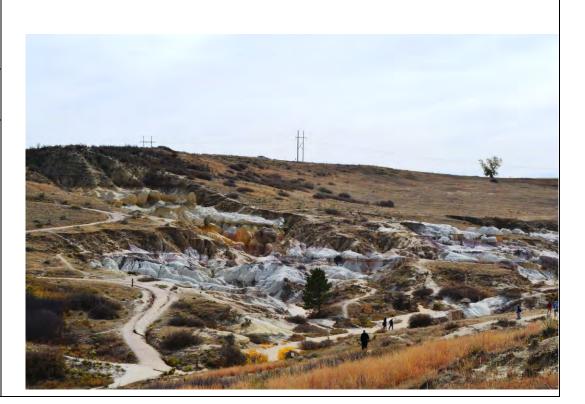
View southeast of White River formation capstone at left, evidence of slumps and glides throughout, and the pediments that are left once the surface materials have completely eroded away.

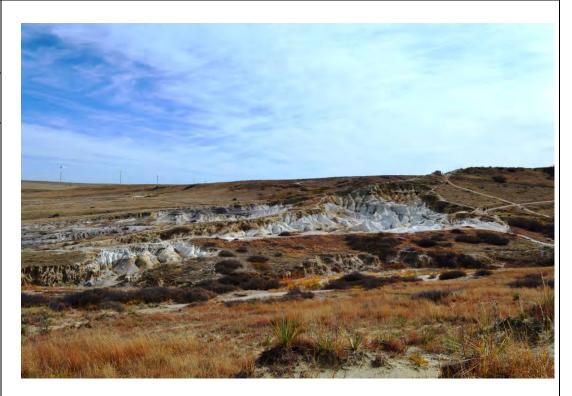
Looking east at area just downstream of the previous view with caprock remnants now at the right, the large glide with site 5EP.3099 above the eroded areas at left, and site 5EP.3098 on the glide remnant near center.

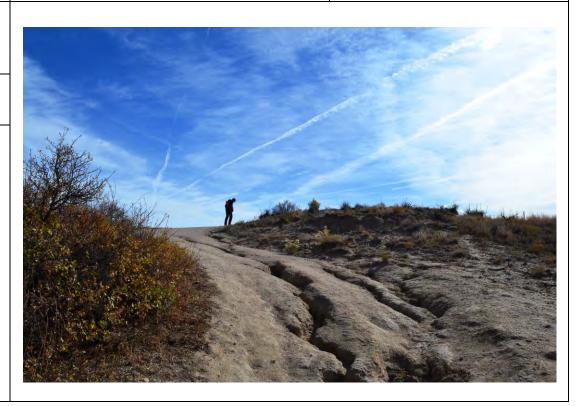
View facing east along east face of main drainage near east-west secondary drainage looking at solum remnant and western edge of site 5EP.3099.

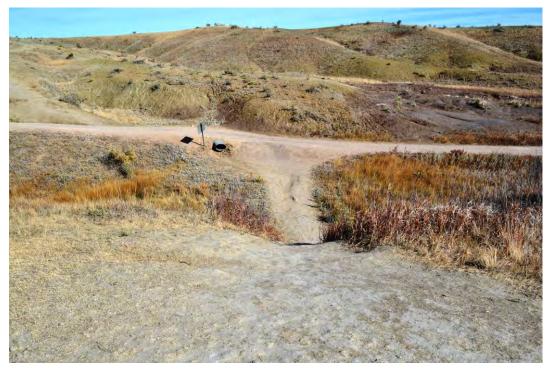
Site 5EP.3119 is located along a ridge-like glide between the Main Parking Lot and the main area of exposed pediments. As can be seen in Photograph DSC_4395 the site is north of the east-west

Looking north at side drainage cut through west side and a slump and glide above the trail in the middle ground with extreme erosion at the right. Site 5EP.3119 is on the high bench near the center.

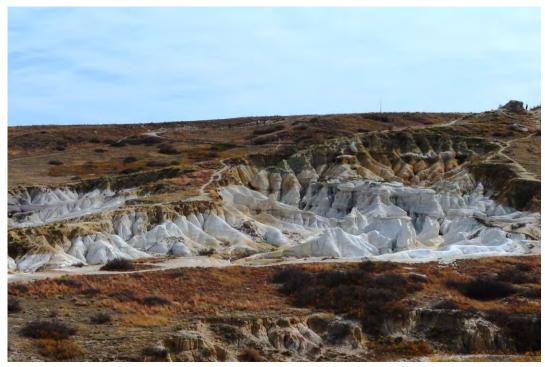
Site 5EP.3098 extends along a finger ridge formed from eroded glide deposits on the east side of the drainage as seen in Photograph DSC_4426c. The site is away from the main trails and was not directly observed during the field survey because it was clear that its location was sufficiently buffered by gullies to preclude any impacts to it by the proposed activities. The proposed activity nearest to this site is the closure of the social trail providing access to the social trail that crosses this site, which will not have any impacts to the site and should reduce that amount foot traffic crossing it. The social trail across the site will not be rehabbed, but a sign discouraging disturbance of the formations will be installed at point #6 on the Sign Plan on page 3 in Attachment 1 near this site. A culvert is planned for installation near the bench at point #11 on the Plan on page 1 of Attachment 1.

Cropped image looking east at site 5EP.3098 along ridgeline extending into badland area in center right.

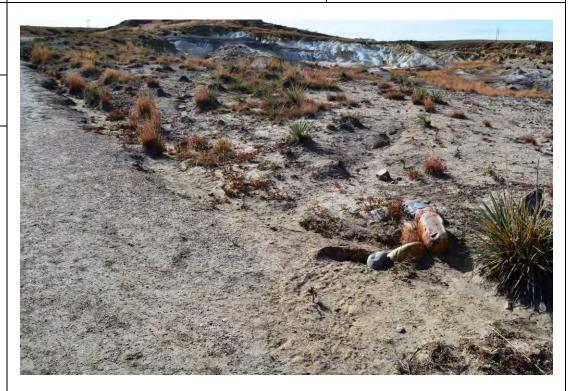
View south-southeast along west edge of site 5EP.3099 and existing trail with existing drainage culvert at lower right.

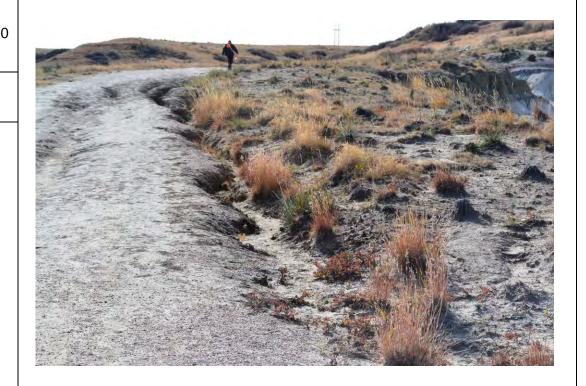
View south-southeast along west edge of site 5EP.3099 and existing trail showing erosion along the trail margin.

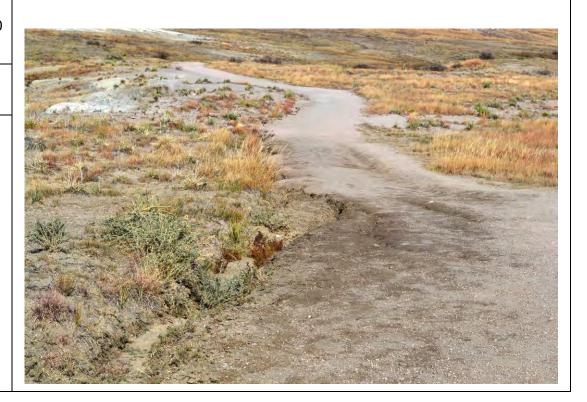
View north-northwest along west edge of site 5EP.3099 and existing trail showing erosion along the trail margin.

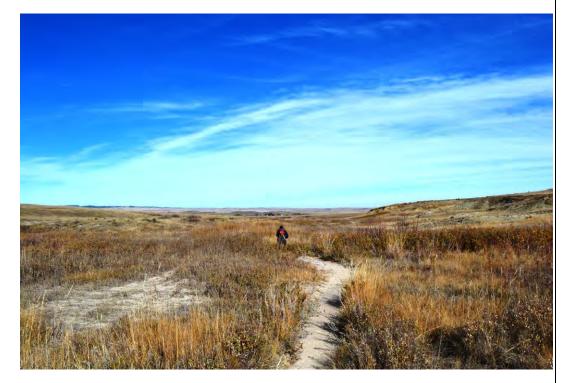
Looking north at site 5EP.3099 on bench at right and site 5EP.3120 on low bench at left. Figure is along trail route.

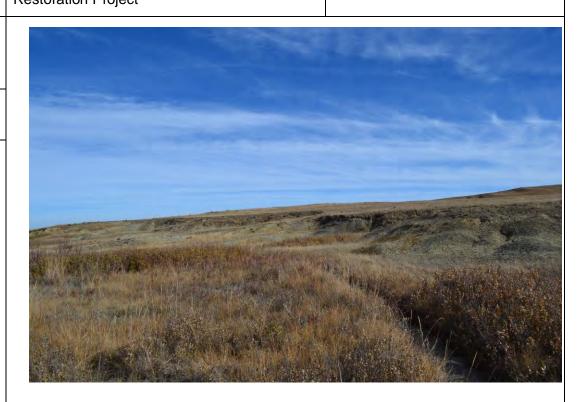
Looking north at site 5EP.3099 on bench and slumps at right middle ground, site 5EP.3107 on bench and slumps in center with trail in right foreground.

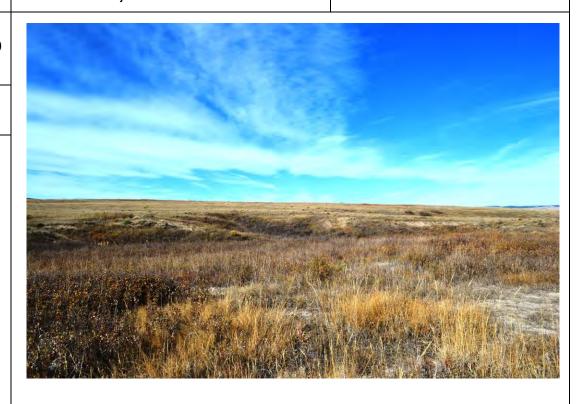
From floodplain looking northwest across site 5EP.3120 on bench and slumps in middle ground.

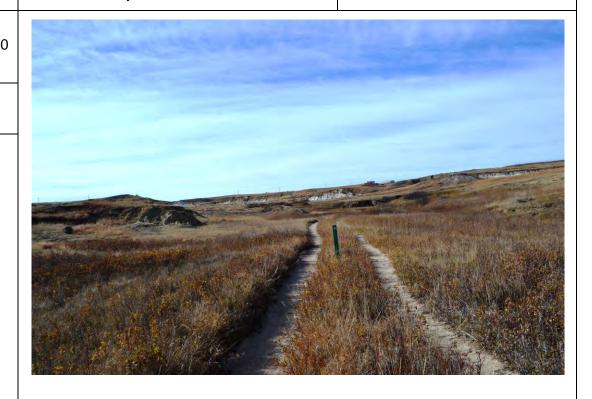
Looking south at site 5EP.3099 on bench and along slumps to the left and site 5EP.3120 on bench and slumps to the right with trail in center.

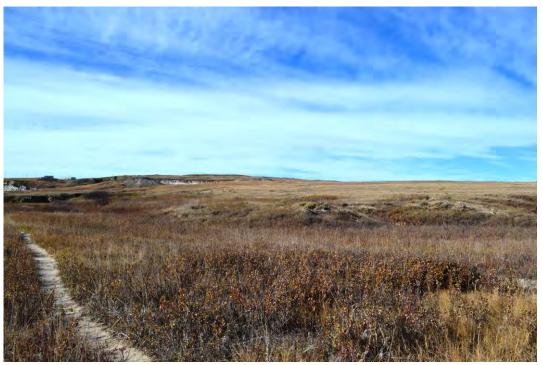
Looking south at site 5EP.3120 on bench and slumps to the right with trail in center.

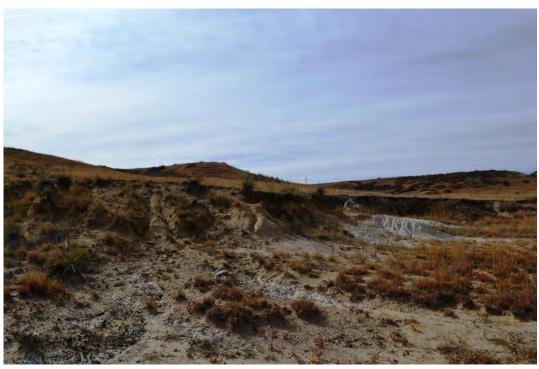
View west-southwest of southern portion of site on bench and along slumps.

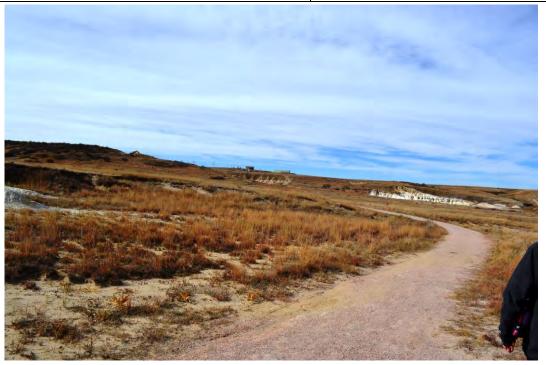
View west along trail at portion that crosses site 5EP.3100 along deflating glide to left.

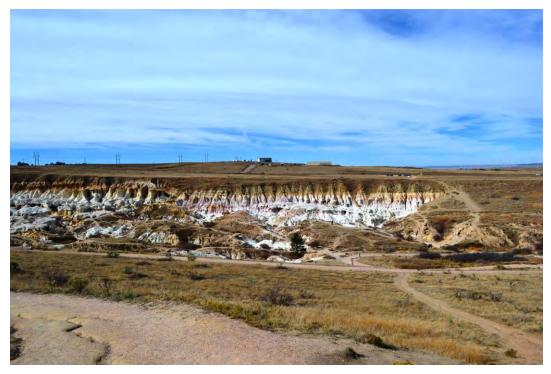
Looking west at the north end of site 5EP.3121 at toe of glide on the far right and the north end of site 5EP.3122 in the area above the breakaway line of the glide and the eroded area to the left.

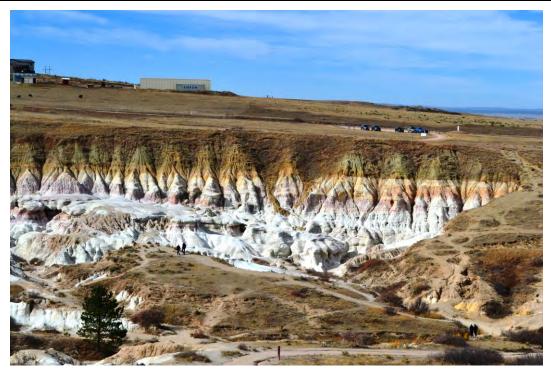
Closer view looking west at the north end of site 5EP.3121 at toe of glide on the far right and the north end of site 5EP.3122 in the area above the breakaway line of the glide and the eroded area to the left.

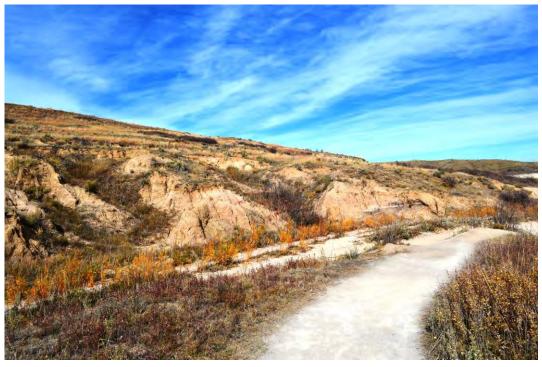
Looking northwest along the toe of glide at base of west side of arroyo and at site 5EP.3121.

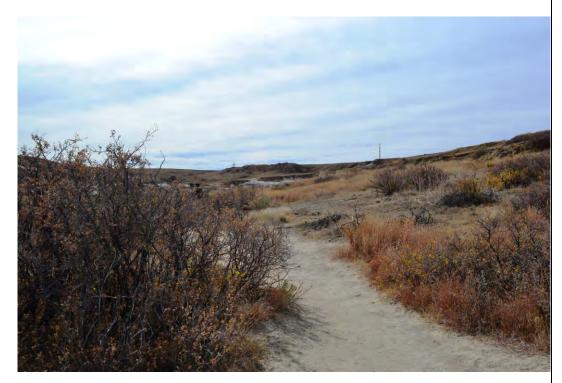
Looking south-southeast along the toe of glide at base of west side of arroyo and at site 5EP.3121 where trail crosses the site.

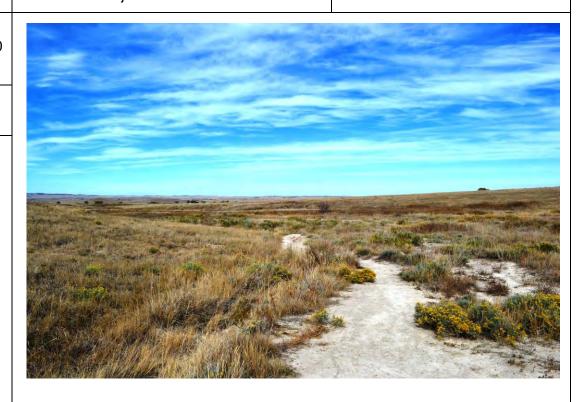
Looking north from drainage bottom and trail at portion of site 5EP.3118 crossed by the trail and east side.

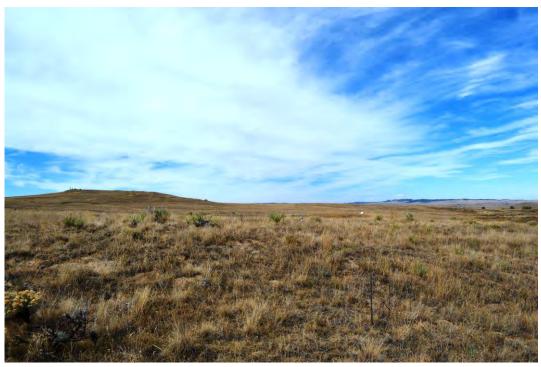
Looking northwest across site 5EP.3118 from east side with Ecology sign near center right.

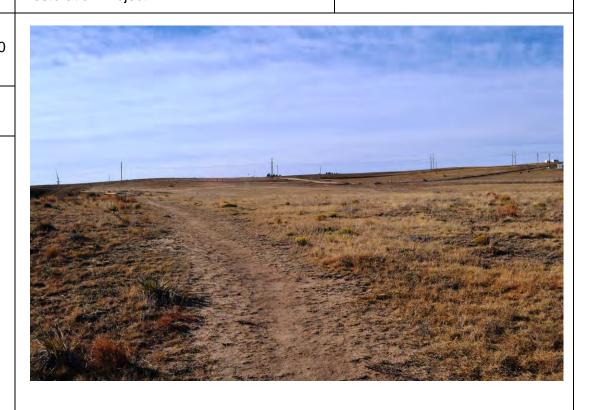
View south of trail along west rim of main arroyo area with site 5EP.3122 away from the trail to the right.

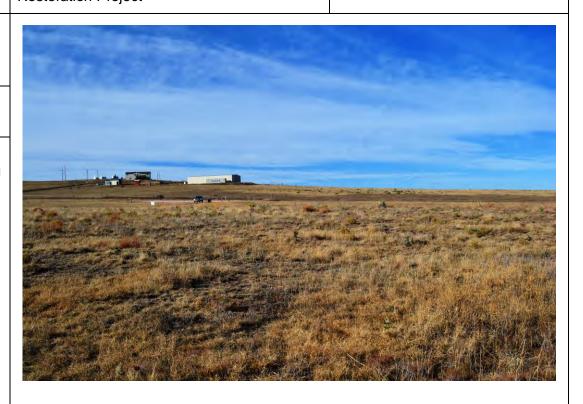
From west from trail along west rim looking across site 5EP.3122.
