GEOTECHNICAL DESIGN REPORT

# Beacon Lite Road Improvements

EL PASO COUNTY, COLORADO

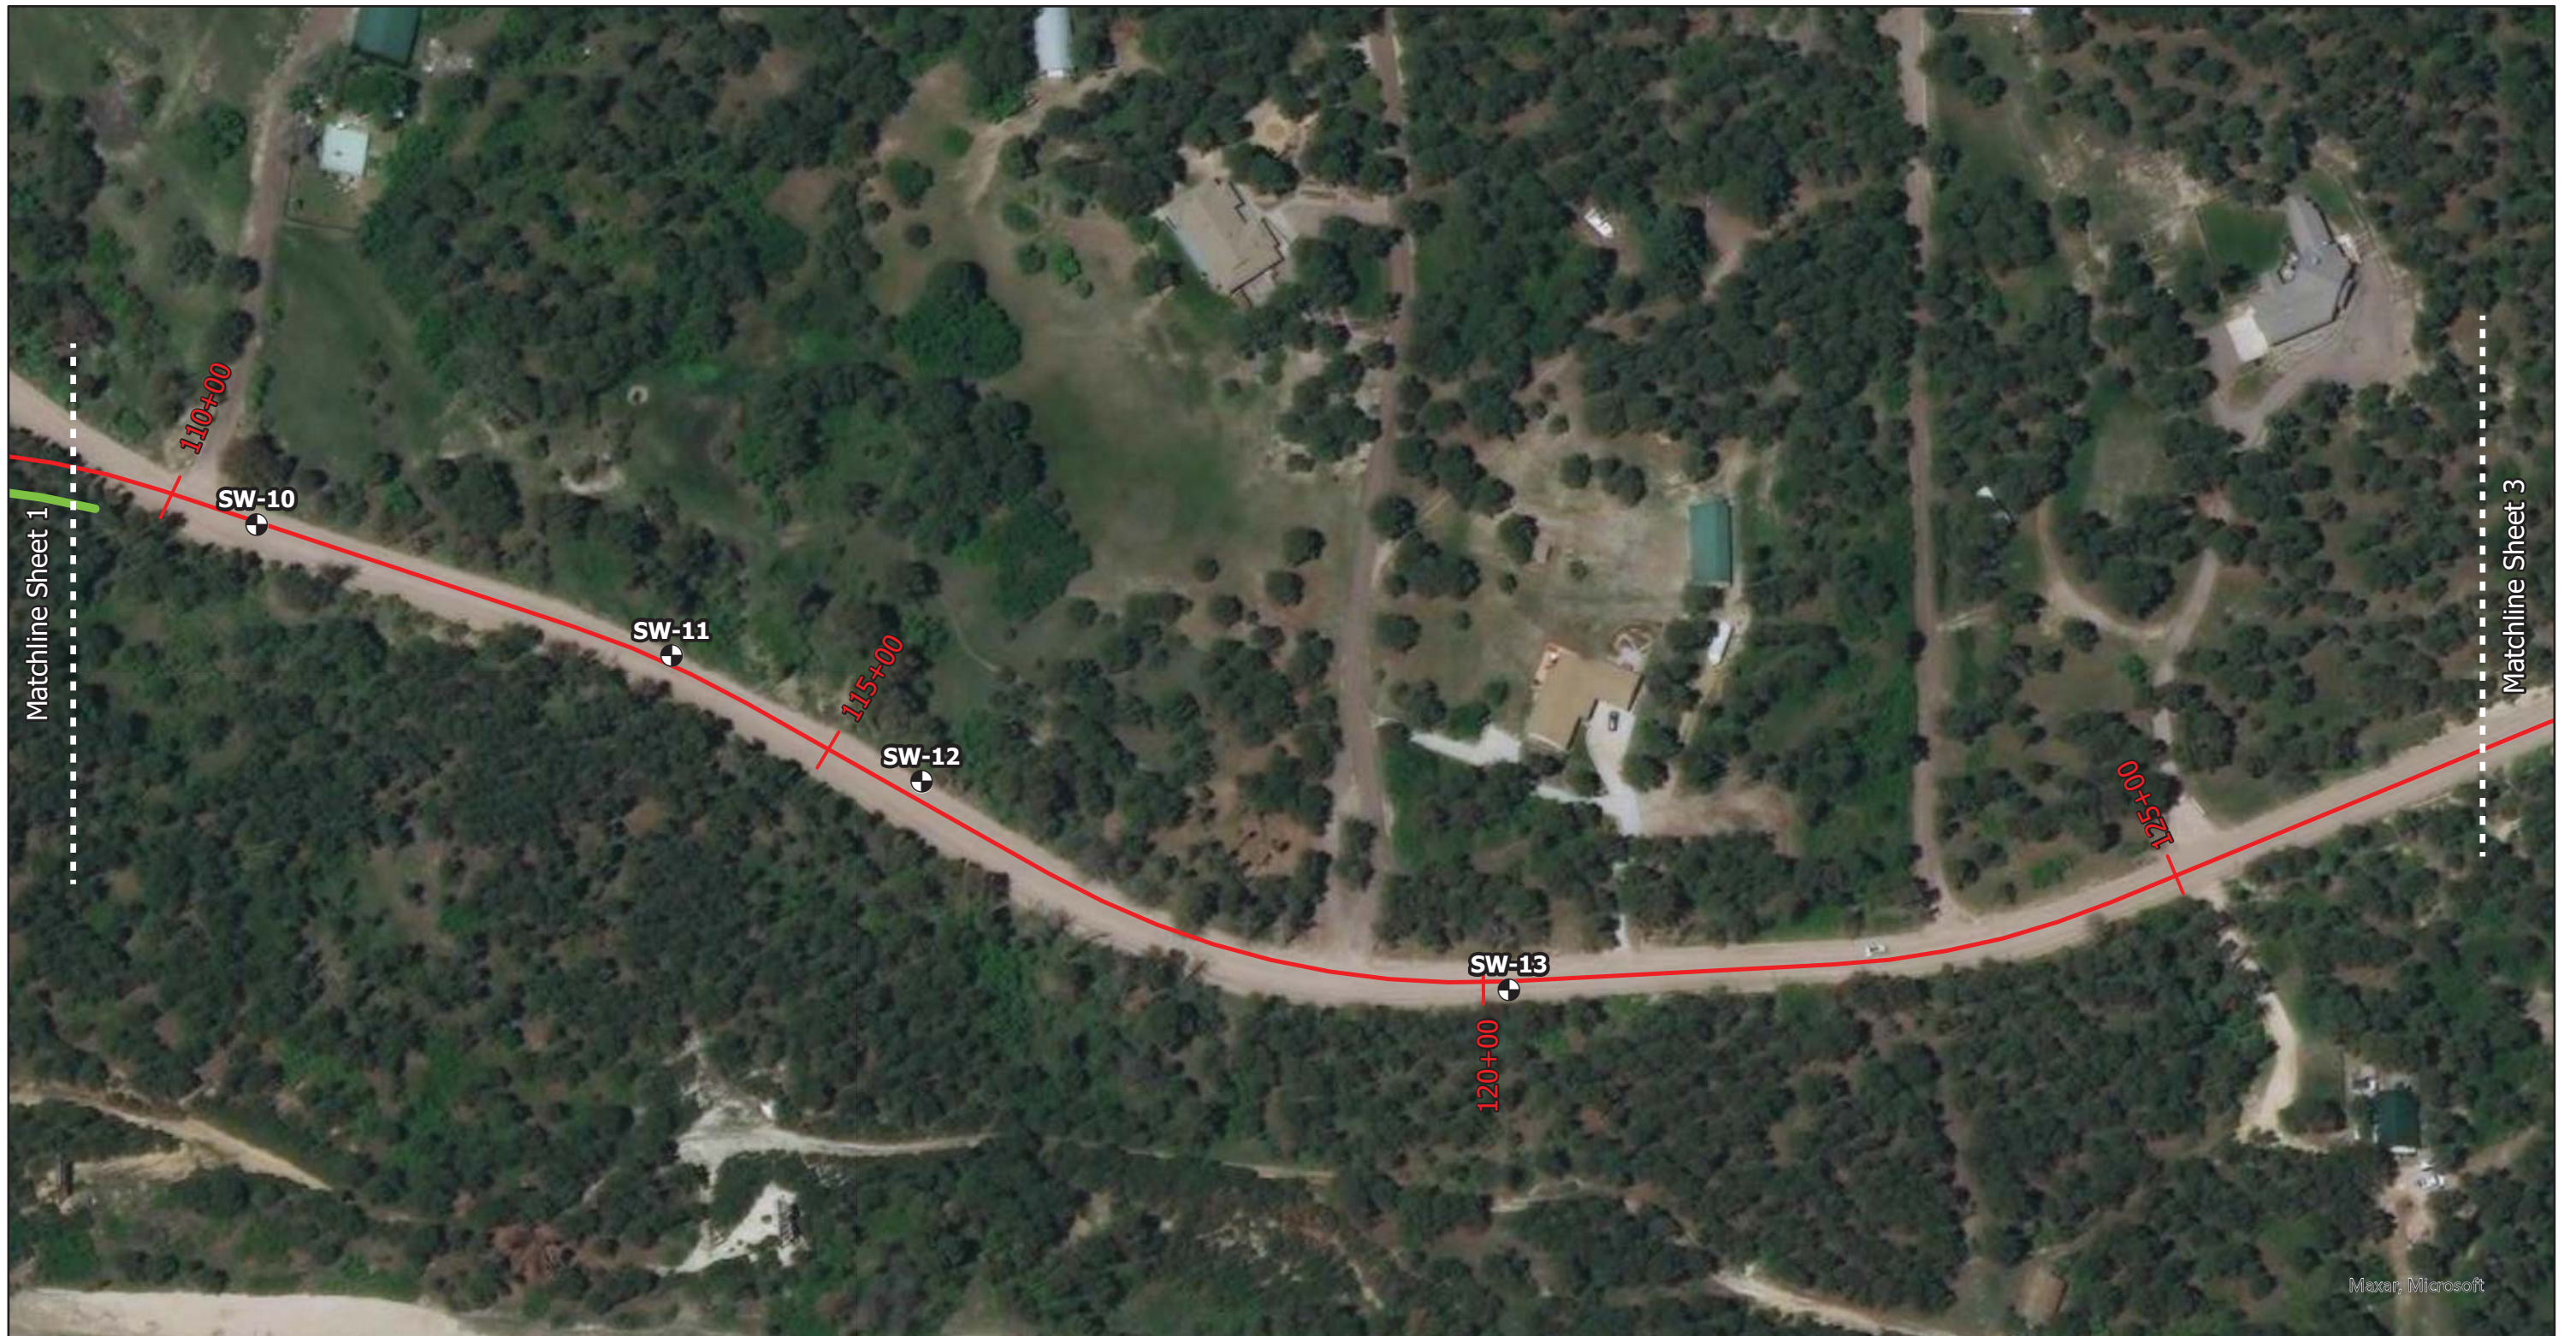
| <b>SHANNON &amp; WILSON, INC.</b><br>Geotechnical and Environmental Consultants | <b>FIG. 2</b><br>Sheet 1 of 4 |

Between approximately Sta. 104+00 and 110+00, the current alignment of Beacon Lite Road is a relatively tight radius curve that traverses around a hill. The existing hill slopes vary from approximately 10 horizontal to 1 vertical (10H:1V) to 5H:1V (Michael Baker, 2021). As shown in Figure 2, the roadway will be realigned in this area using a through-cut. The cut will be approximately 600 feet long with a maximum height of 32 feet and have side slopes of 3H:1V. The existing alignment of Beacon Lite Road has exposed rock cuts (up to 5 feet high). Bedrock in the cut appears to be raveling, which results in accumulations of loose, sandy material forming flatter surfaces.
