**GEOTECHNICAL INVESTIGATION
JANITELL BRIDGE
FOUNTAIN CREEK
EL PASO COUNTY, COLORADO**

**Alfred Benesch & Company
7979 E. Tufts Avenue, Suite 800
Denver, Colorado 80237**

CTL|T Project No. CS19402-125

September 28, 2021

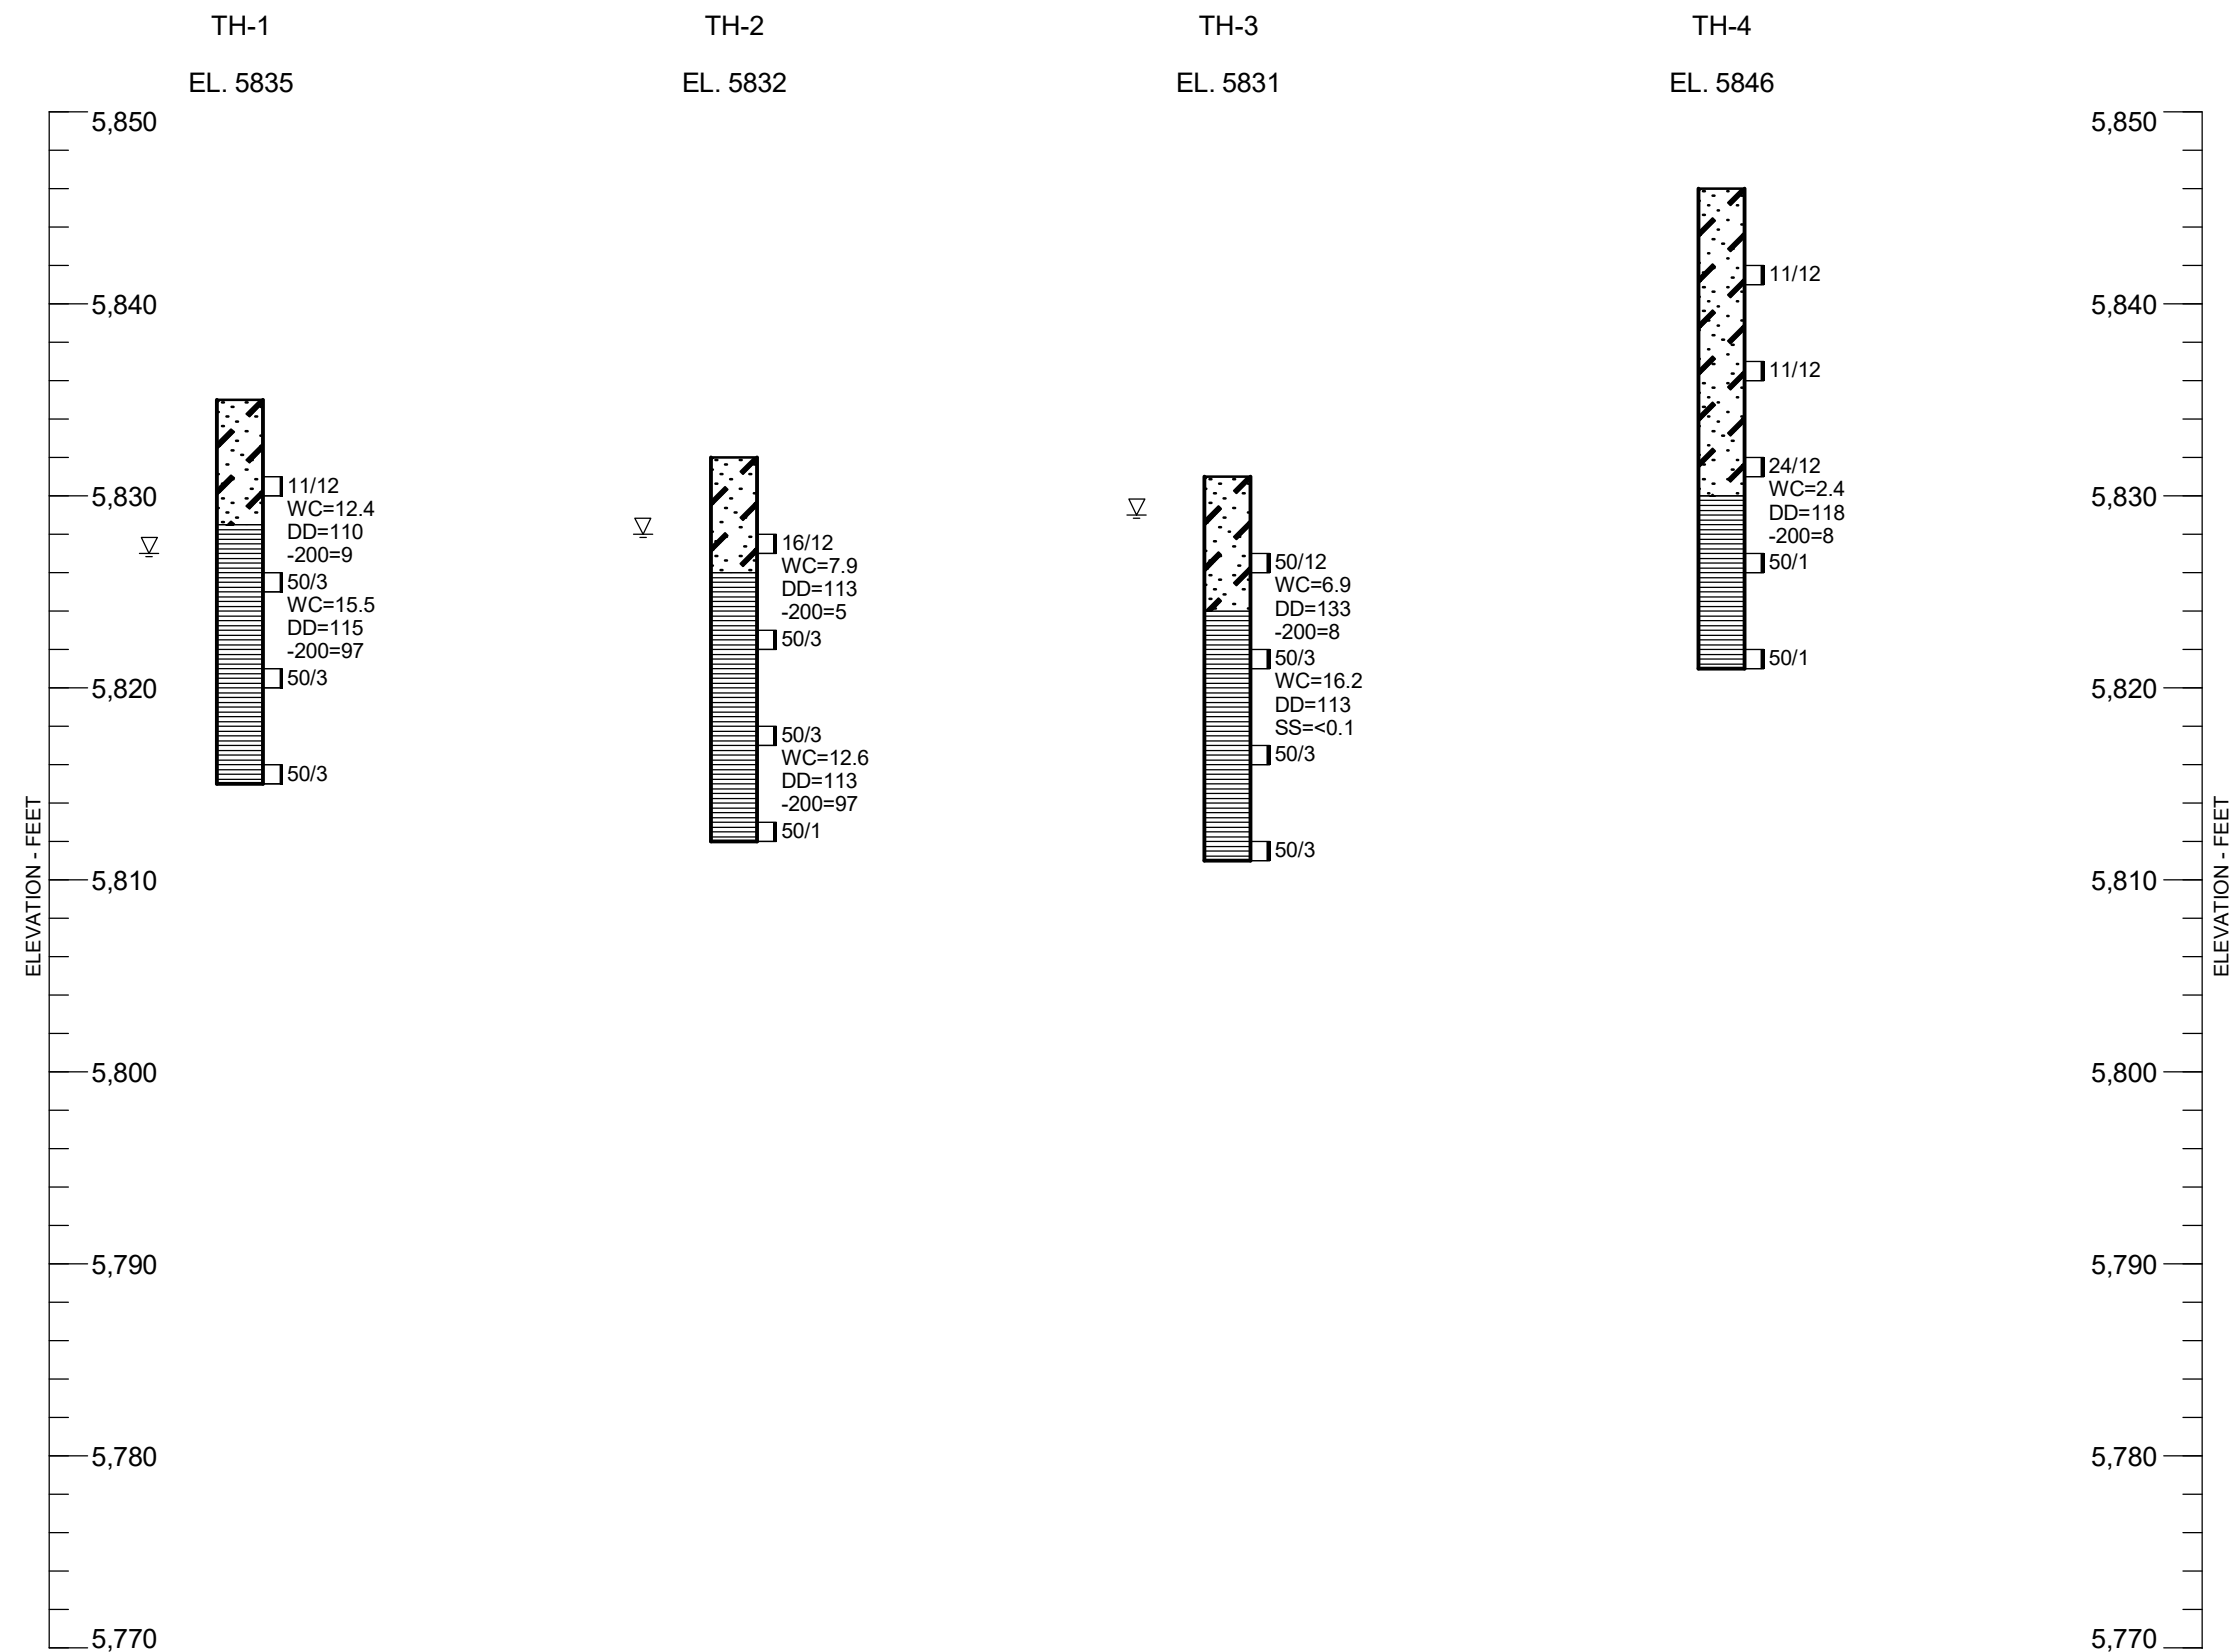
Summary Logs of
Exploratory
Borings

The three borings drilled below the bridge encountered 6 to 7 feet of slightly clayey to very clayey sand and gravel overlying shale bedrock. The surficial soils may have been fill adjacent to the trail (TH-1) or were deposited as part of the gravel bar (TH-2 and TH-3). Cobble, up to potentially small boulder material was observed as part of the gravel bar. Larger particles, over about 1.5 to 2 inches, would have been excluded from the samples.

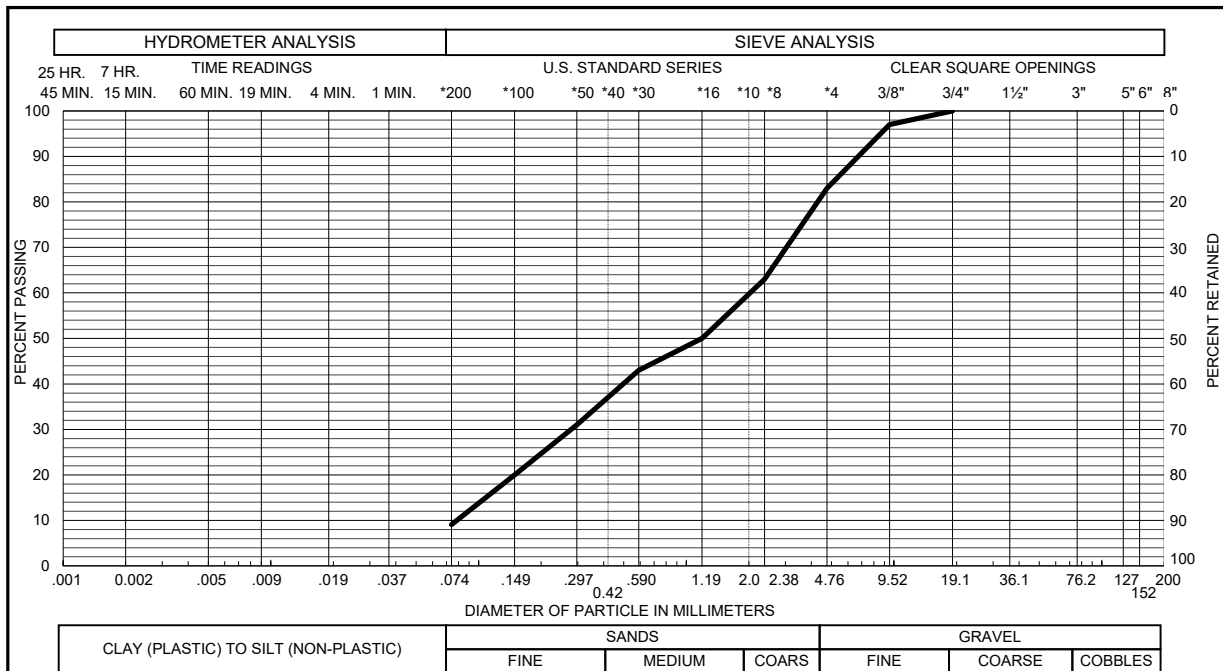
Sample of SAND, SLIGHTLY CLAYEY, WITH GRAVEL (SP-SC) GRAVEL 17 % SAND 74 %
From TH - 1 AT 4 FEET SILT & CLAY 9 % LIQUID LIMIT %
PLASTICITY INDEX %

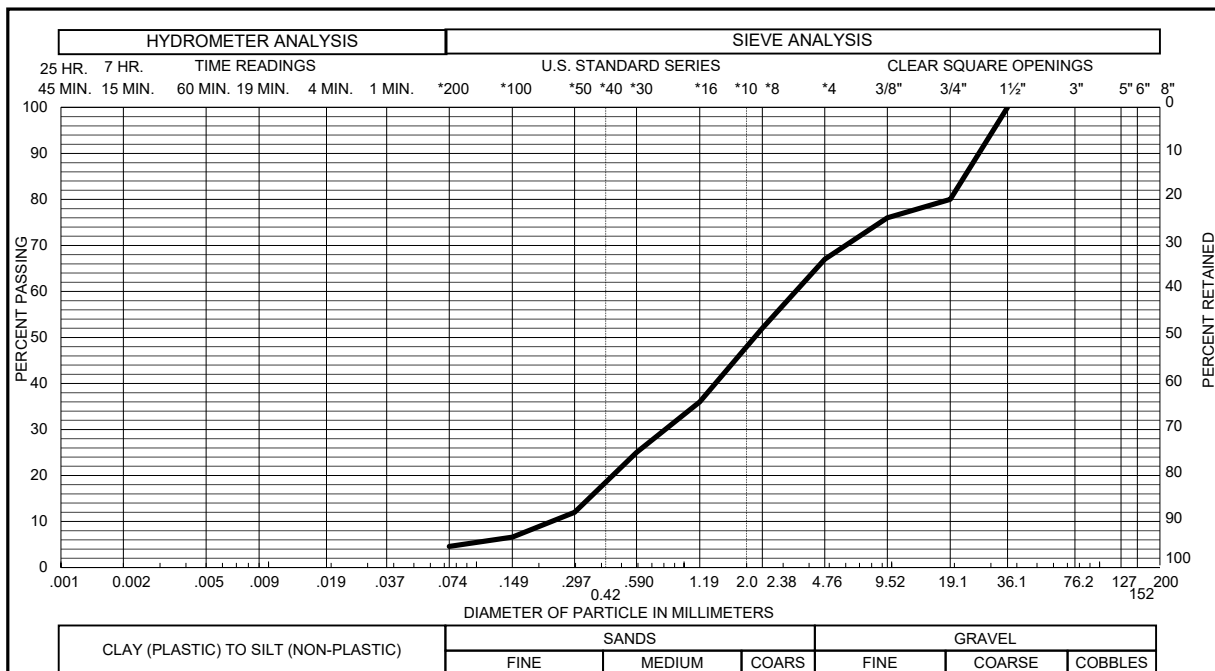
Sample of SAND, SLIGHTLY CLAYEY, WITH GRAVEL (SP-SC) GRAVEL 33 % SAND 62 %
From TH - 2 AT 4 FEET SILT & CLAY 5 % LIQUID LIMIT %
PLASTICITY INDEX %

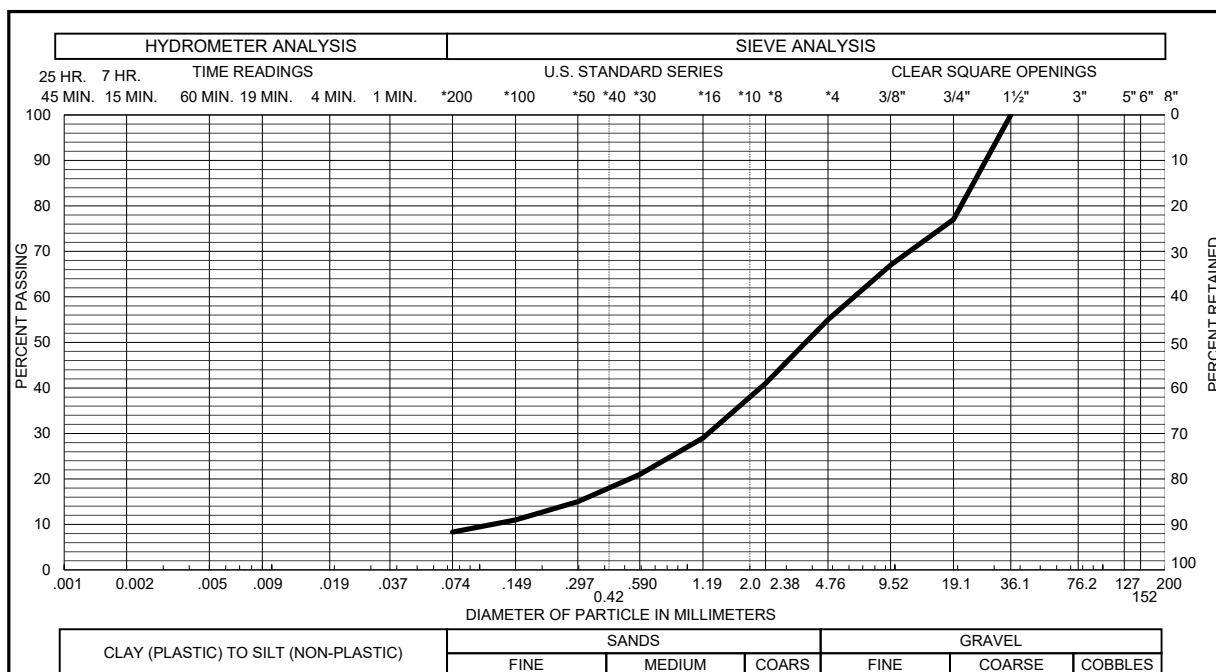
Sample of SAND, SLIGHTLY CLAYEY, WITH GRAVEL (SP-SC) GRAVEL 45 % SAND 47 %
From TH - 3 AT 4 FEET SILT & CLAY 8 % LIQUID LIMIT %
PLASTICITY INDEX %

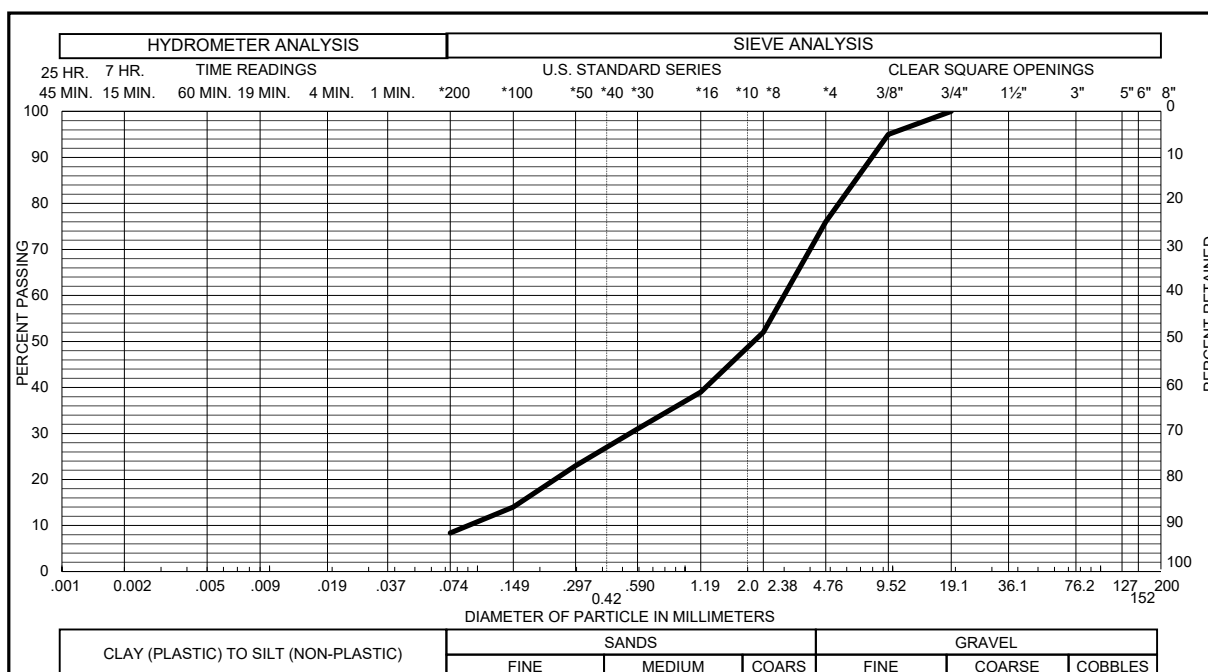
Sample of SAND, SLIGHTLY CLAYEY, WITH GRAVEL (SP-SC) GRAVEL 24 % SAND 68 %
From TH - 4 AT 14 FEET SILT & CLAY 8 % LIQUID LIMIT %
PLASTICITY INDEX %

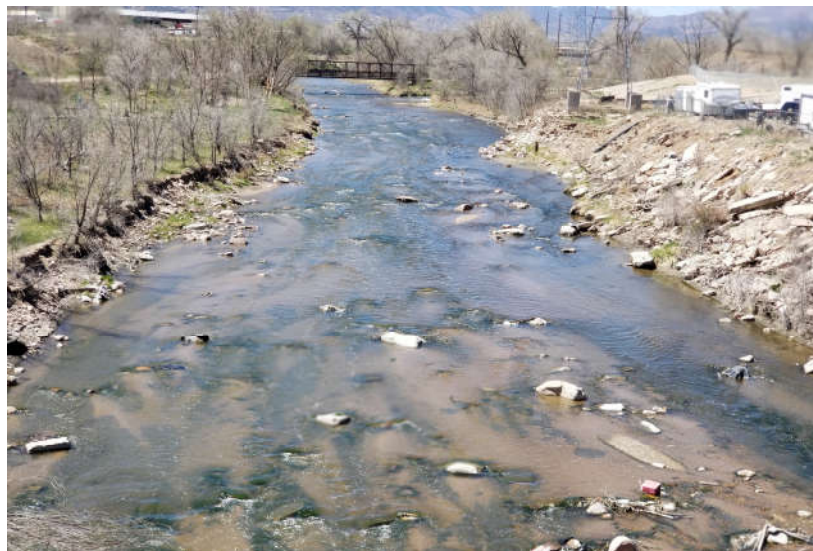
1. Upstream from the bridge.

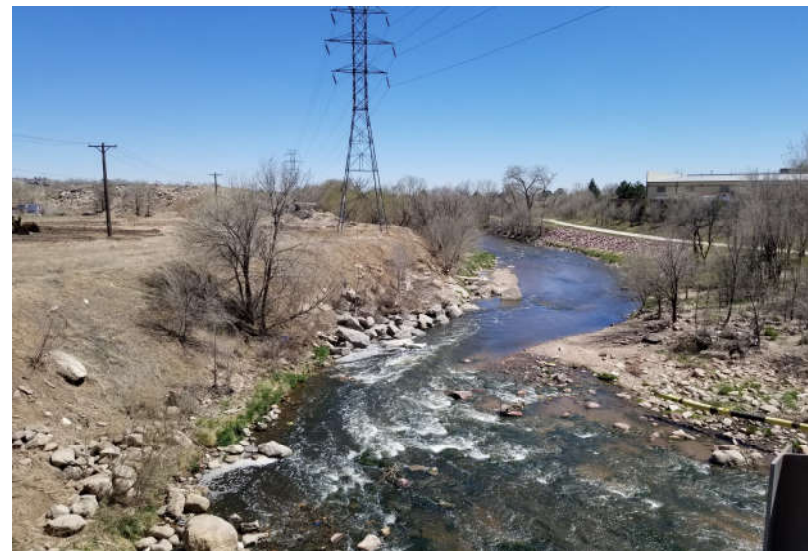
2. Downstream from the bridge.

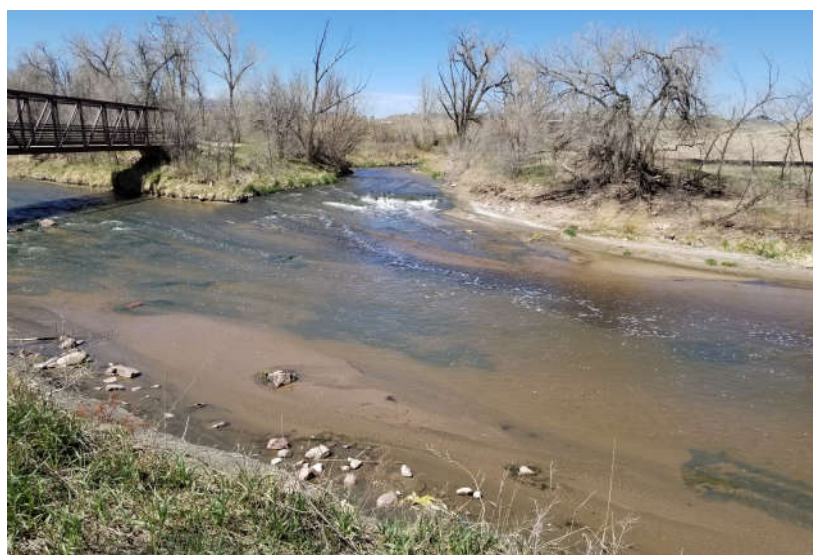
3. Confluence of Spring Creek northwest of the bridge.

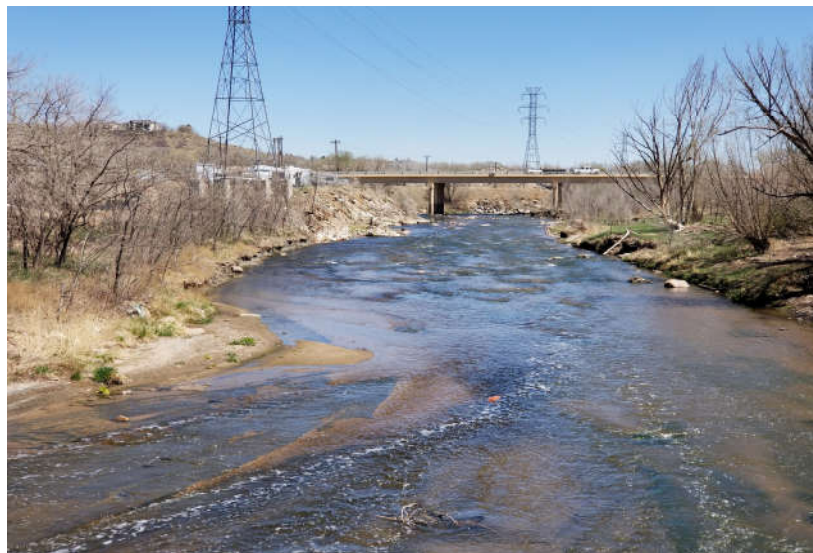
5. Janitell Bridge from upstream.
