FINAL REPORT
GEOTECHNICAL ENGINEERING STUDY
DEER CREEK ROAD, BASE CAMP ROAD,
AND MICROSCOPE WAY
EL PASO COUNTY, COLORADO

Project No. 19-2-195

**Proposed Deer Creek Road Roundabout
Intersection of Deer Creek Road and Woodmoor Drive
El Paso County, Colorado
VIVID Project No.: D23-2-711**

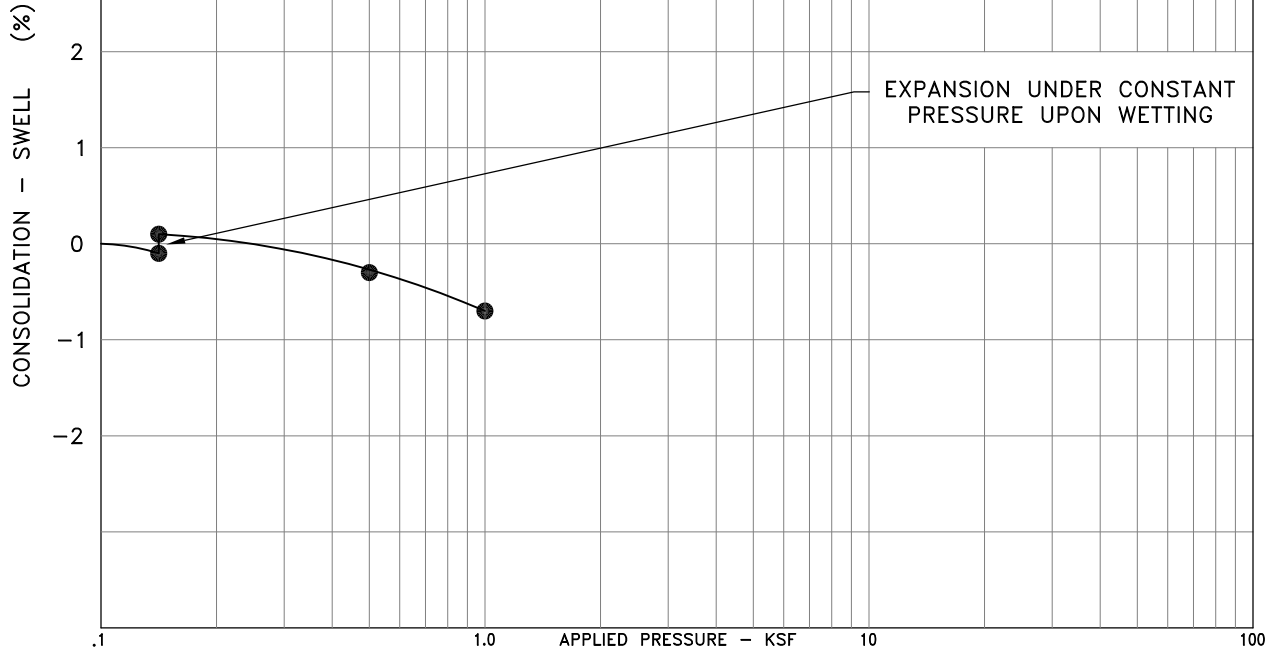
SAMPLE OF: Clayey Sand (SC)
 FROM: Boring 4 @ 4'
 WC = 11.4 %, DD = 119.0 pcf

Swell-consolidation test results presented on Figs. 4 and 5 indicate the tested samples of clayey sandstone, clayey sand and sandy fat clay had a nil to very low swell potential at the moisture contents tested. Of the samples tested, a maximum swell of 0.2% was measured upon wetting with a 150 psf surcharge. Additional swell-consolidation tests were performed on samples of the clayey sand remolded to approximately 95% of their maximum standard Proctor density (ASTM D 698) at a moisture content approximately equal to the optimum value. Under a 150-psf surcharge, the samples were non-expansive to slightly expansive (nil to +0.7%). The soil moisture-density relationships (Proctors) are presented on Figs. 13 and 14, and remolded swell consolidation test results are presented on Fig. 15.

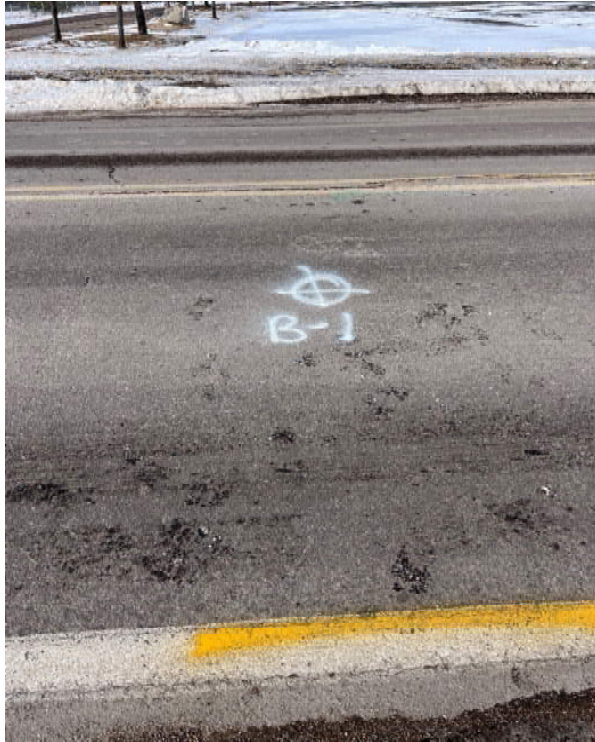
LOCATION OF BORING B-1 - LOOKING WEST

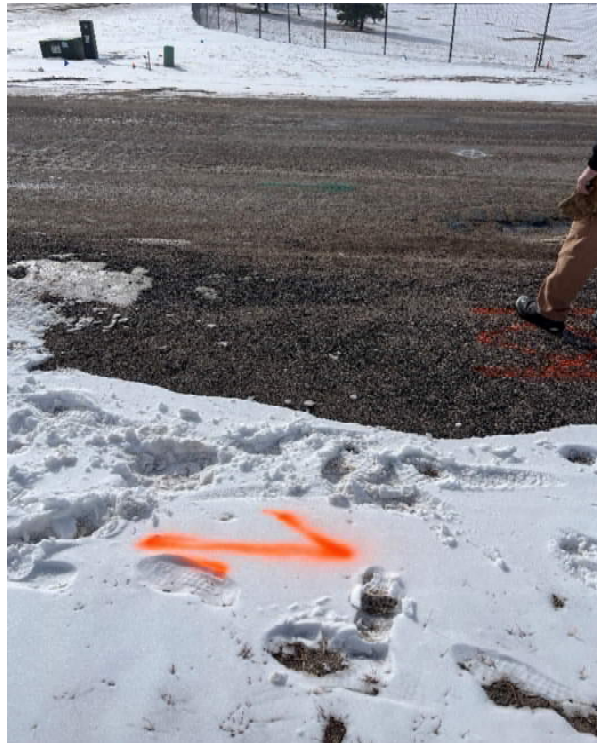
LOCATION OF BORING B-2 - LOOKING SOUTH

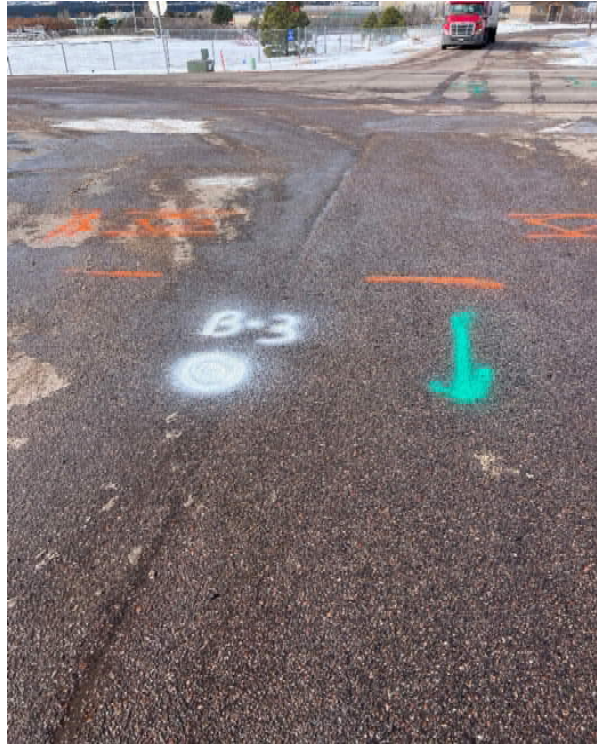
LOCATION OF BORING B-3 - LOOKING WEST
