ASSET MANAGEMENT PLAN

2022

EL PASO

**COUNTY**
COLORADO

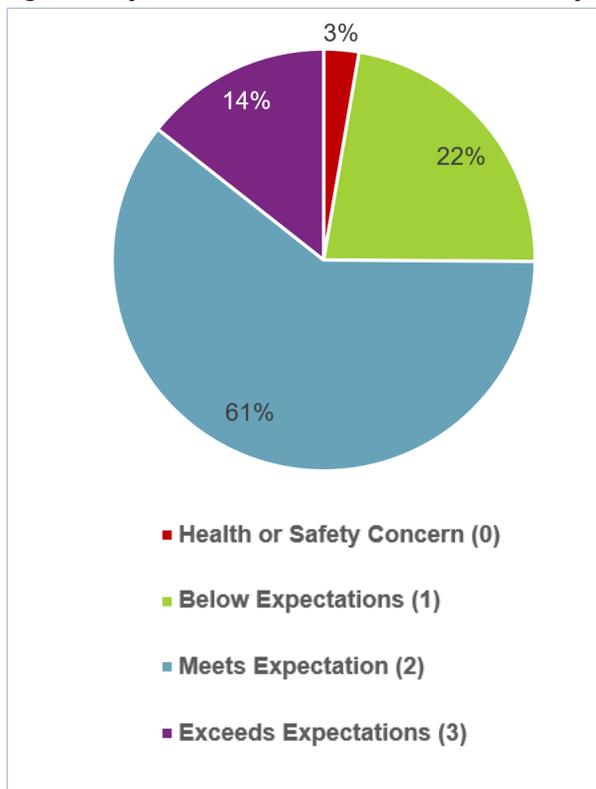
Figure 1: System Condition Assessment Summary

The assessment found 25% of components evaluated scored a “0” or a “1. While 75% of components are meeting or exceeding expectations. Based on the results of the inventory assessment Capital Improvements have been designated as:

- 0 or 1: Short-term (Critical 1 – 3 years)
- 2: Mid-term (4 – 7 years)
- 3: Long-term (8 – 10 years)

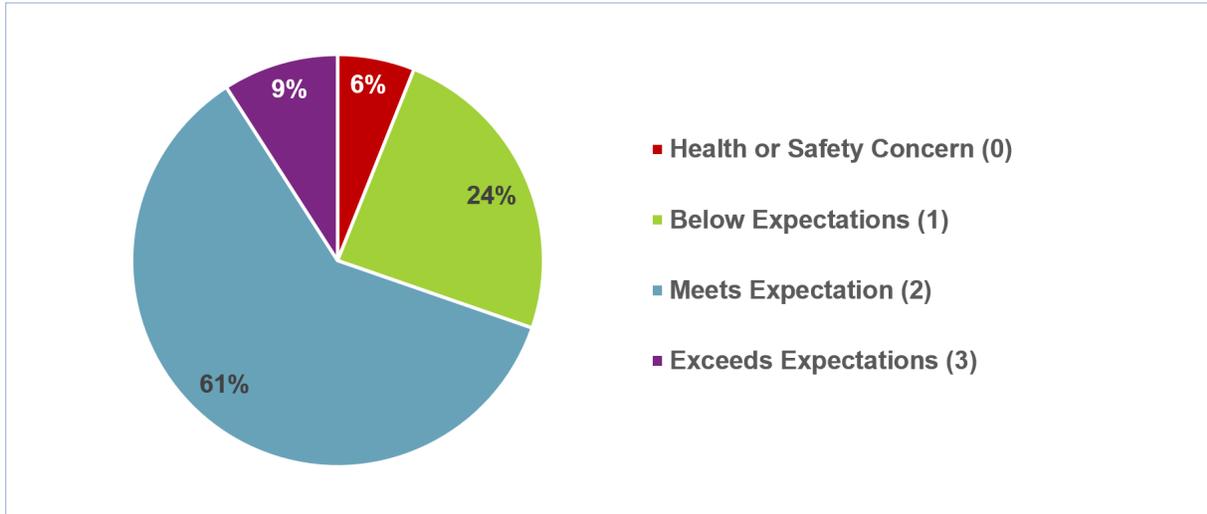
Figure 3: Bear Creek Regional Park Condition Assessment Summary

During the asset inventory field visit, each asset was assessed and given a condition rating. The figure below summarizes the results of the condition assessment.

In total, there are 33 assets located within Bear Creek Regional Park. The sum of all Capital Improvement needs is estimated, in 2022 dollars, to be approximately \$5.4 million. This estimate accounts for component replacement or repair, irrigation upgrades and hardscape need in the next 10 years. Short-term Capital Improvements are considered “Critical Need”. These include Health or **Safety Concerns** and components identified as being **Below Expectations**.

- The Playgrounds at Bear Creek are still functional but should be incorporated into a replacement schedule (this will alleviate the financial burden of having to replace multiple playgrounds at one time in the future).
- As a Regional Park, Bear Creek maintains a great opportunity to replace the main playground with a customized destination playground.
- The Tennis Courts are in significant need of upgrade (repair, resurfacing, and lighting).
- The main pavilions need significant concrete repairs. Given the extent of cracked and upheaval conditions, figures were not included in the ROM table and will require a separate, more extensive evaluation.

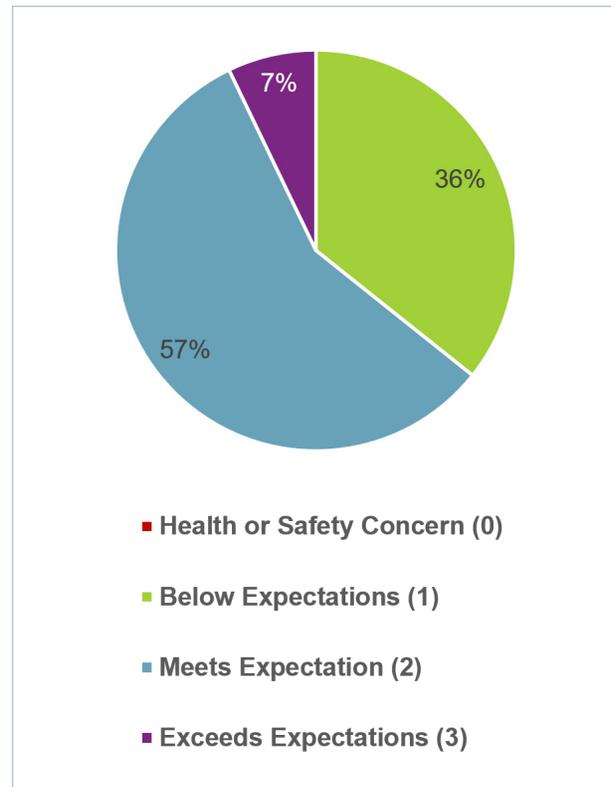
Figure 4: Black Forest Regional Park Condition Assessment Summary

During the asset inventory field visit, each asset was assessed and given a condition rating. The figure below summarizes the results of the condition assessment.

In total, there are 14 assets located within Black Forest Regional Park. The sum of all Capital Improvement needs is estimated, in 2022 dollars, to be approximately \$1.6 million. This estimate accounts for component replacement or repair, irrigation upgrades and hardscape need in the next 10 years. Short-term Capital Improvements are considered “Critical Need”. These include Health or *Safety Concerns* and components identified as being *Below Expectations*.

- The playground is still functional but should be incorporated into a replacement schedule (this will alleviate the financial burden of having to replace multiple playgrounds at one time in the future).
- Tennis court surfacing is in significant need of repair.
- Basketball backboards are awkwardly located on tennis courts and should be considered for relocation.
- The gravel drive to the upper parking lot is in significant need of repair and should be paved for improved accessibility.

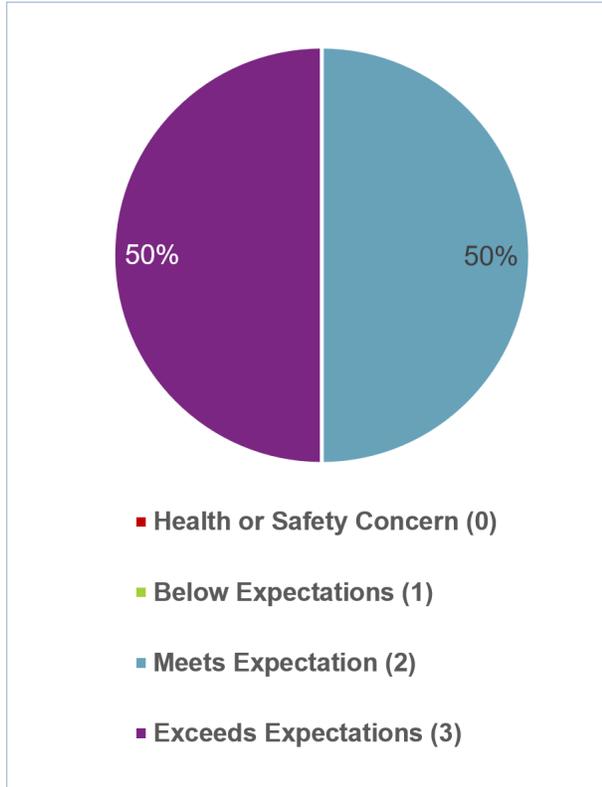
Figure 5: Falcon Regional Park Condition Assessment Summary

During the asset inventory field visit, each asset was assessed and given a condition rating. The figure below summarizes the results of the condition assessment.

In total, there are 8 assets located within Falcon Regional Park. The sum of all Capital Improvement needs is estimated, in 2022 dollars, to be approximately \$28,000. This estimate accounts for component replacement or repair, irrigation upgrades and hardscape need in the next 10 years.

- Given the openness of the location, furnishings (shade structures, windbreaks) should be considered to assist visitors in combating natural elements (high winds, sun).

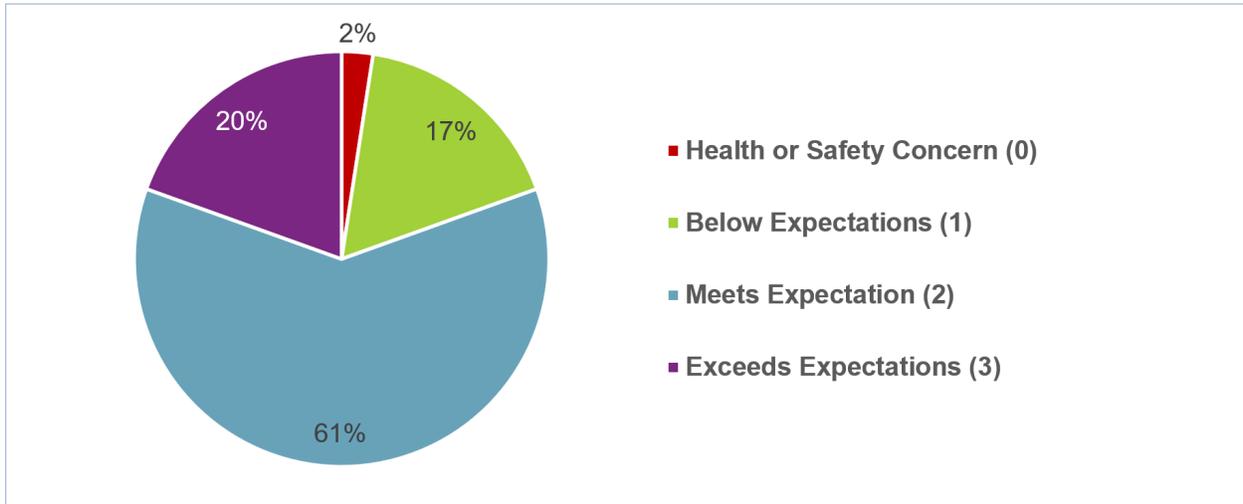
Figure 6: Fountain Creek Regional Park Condition Assessment Summary

During the asset inventory field visit, each asset was assessed and given a condition rating. The figure below summarizes the results of the condition assessment.

In total, there are 41 assets located within Fountain Creek Regional Park. The sum of all Capital Improvement needs is estimated, in 2022 dollars, to be approximately \$4 million. This estimate accounts for component replacement or repair, irrigation upgrades and hardscape need in the next 10 years. Short-term Capital Improvements are considered “Critical Need”. These include Health or **Safety Concerns** and components identified as being **Below Expectations**.

- Playgrounds are still functional but should be incorporated into a replacement schedule (this will alleviate the financial burden of having to replace multiple playgrounds at one time in the future).
- Drives and parking lots were observed to maintain periodic cracking, upheaval, and potholes that may be spot repaired or repaved in their entirety to maintain consistency (as the more costly of the two options, the latter was included in the ROM tables).

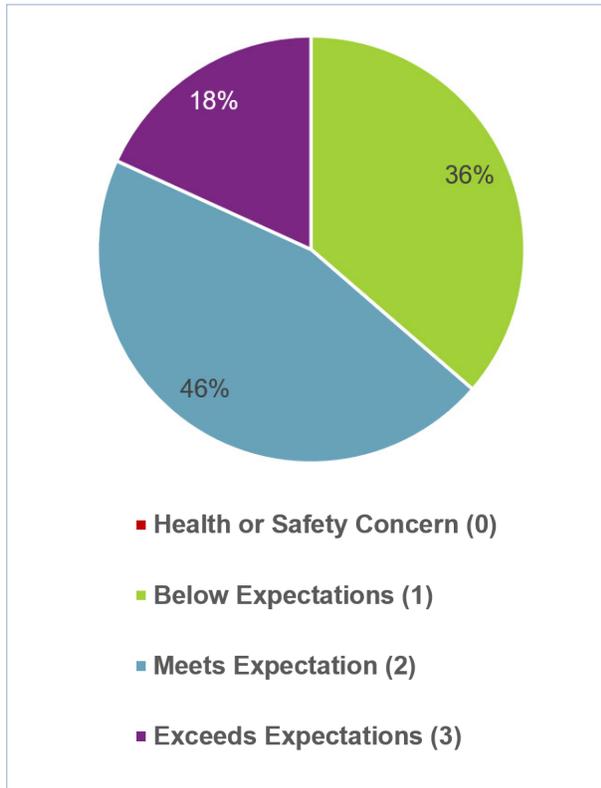
Figure 7: Fox Run Regional Park Condition Assessment Summary

During the asset inventory field visit, each asset was assessed and given a condition rating. The figure below summarizes the results of the condition assessment.

In total, there are 26 assets located within Fox Run Regional Park. The sum of all Capital Improvement needs is estimated, in 2022 dollars, to be approximately \$8.6 million. This estimate accounts for component replacement or repair, irrigation upgrades and hardscape need in the next 10 years. Short-term Capital Improvements are considered “Critical Need”. These include Health or **Safety Concerns** and components identified as being **Below Expectations**.

- The Oak Meadow playground is still functional but should be incorporated into a replacement schedule (this will alleviate the financial burden of having to replace multiple playgrounds at one time in the future).

- Gravel drives and parking lots need repair/maintenance and given their proneness to washout should be considered for pavement.
- The irrigation system needs a separate, more extensive evaluation.

- The Roller Coaster restroom has a vault toilet and leach field. The restroom should be connected to sewer and requires ADA updates.

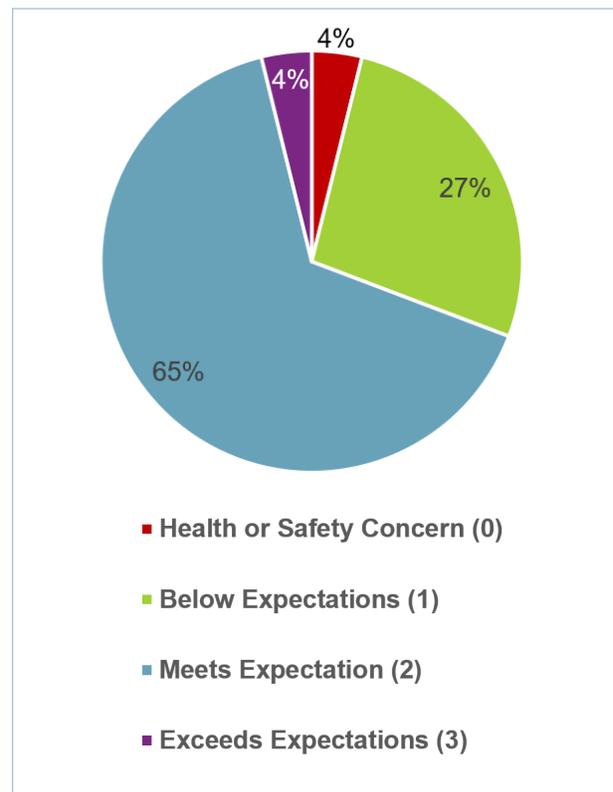
Figure 8: Homestead Ranch Regional Park Condition Assessment Summary

During the asset inventory field visit, each asset was assessed and given a condition rating. The figure below summarizes the results of the condition assessment.

In total, there are 21 assets located within Homestead Ranch Regional Park. The sum of all Capital Improvement needs is estimated, in 2022 dollars, to be approximately \$1.7 million. This estimate accounts for component replacement or repair, irrigation upgrades and hardscape need in the next 10 years. Short-term Capital Improvements are considered “Critical Need”. These include **Health or Safety Concerns** and components identified as being **Below Expectations**.

- Playgrounds are still functional but should be incorporated into a replacement schedule (this will alleviate the financial burden of having to replace multiple playgrounds at one time in the future).

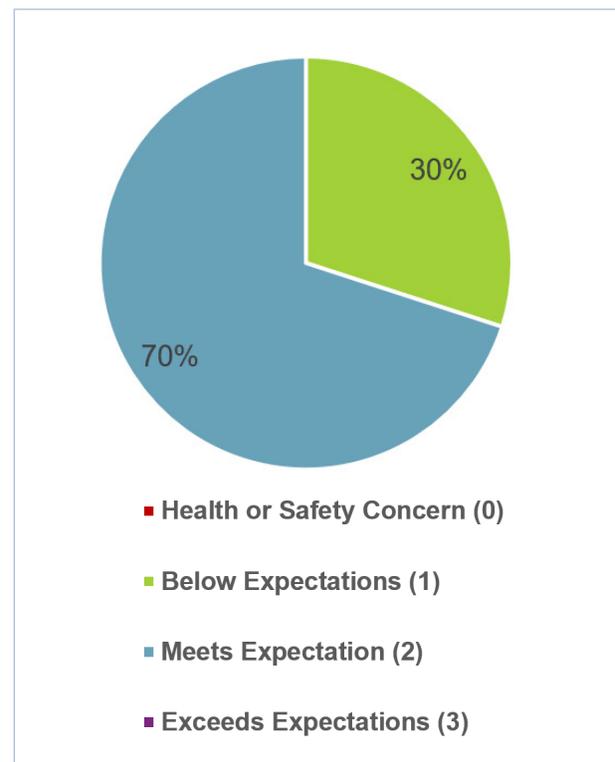
Figure 9: Stratmoor Valley Park Condition Assessment Summary

During the asset inventory field visit, each asset was assessed and given a condition rating. The figure below summarizes the results of the condition assessment.

In total, there are 19 assets located within Stratmoor Valley Park. The sum of all Capital Improvement needs is estimated, in 2022 dollars, to be approximately \$530,000. This estimate accounts for component replacement or repair, irrigation upgrades and hardscape need in the next 10 years. Short-term Capital Improvements are considered "Critical Need". These include Health or Safety Concerns and components identified as being Below Expectations.

- The Playgrounds is still functioning but should be incorporated into a replacement schedule in the next 3 years. It is not ADA compliant and there are missing and damaged elements.

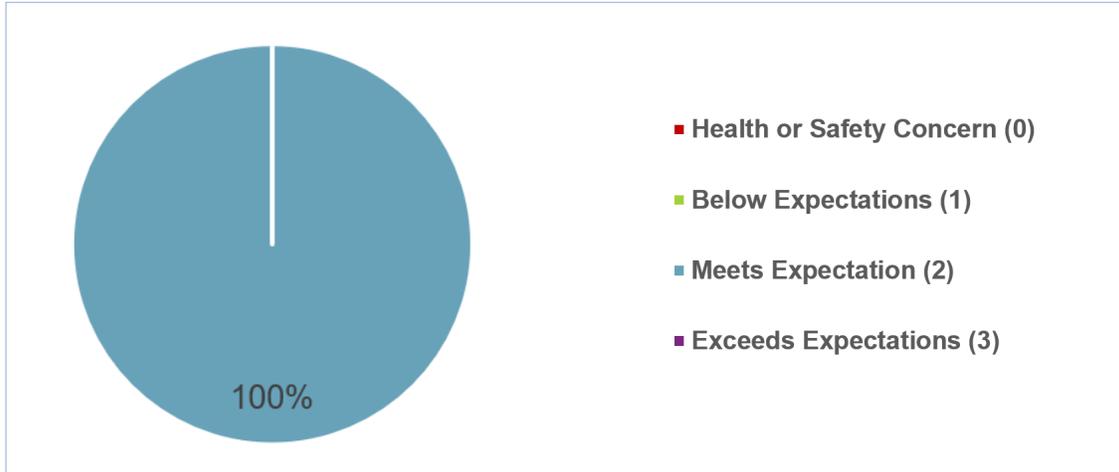
Figure 12: Stratmoor Hills Park Condition Assessment Summary

In total, there are 7 assets located within Stratmoor Hills Park. All components at the park were found to meet expectations. There are no Capital Improvement estimates for the park at this time.

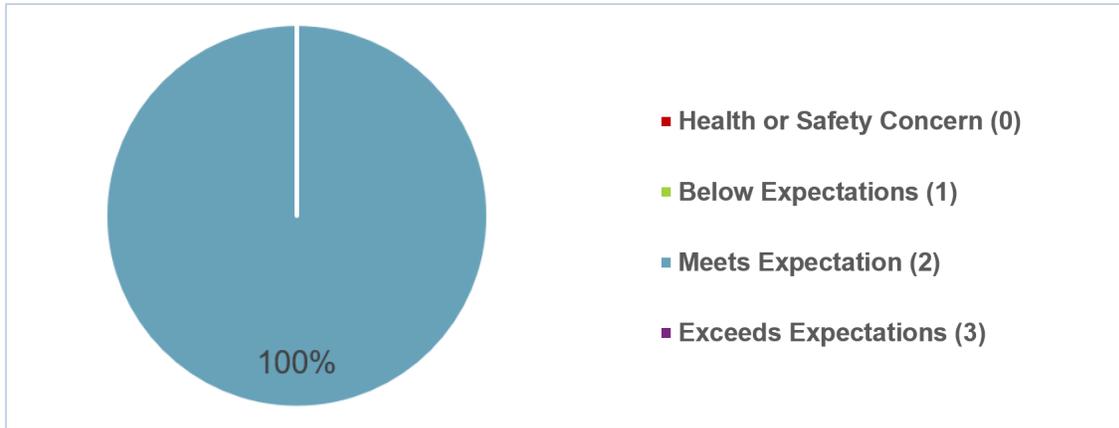
Figure 14: Paint Mines Interpretive Park Condition Assessment Summary

In total, there are 5 assets located within Paint Mines Interpretive Park. All components at the facility were found to meet expectations. There are no Capital Improvement estimates at this time. A master plan of the park is planned which will outline future improvements.
