Janitell Bridge over Fountain Creek Scour Protection Project

Structure No. EPC 0377-00.50A

Final Drainage Report

December 2022

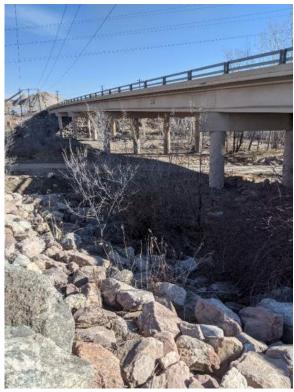
Looking north from upstream.

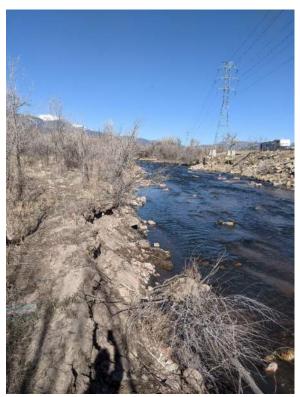
Looking upstream, south bank.

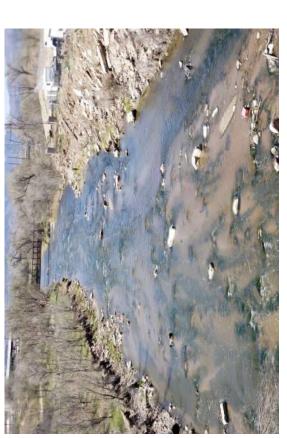
1. Upstream from the bridge.

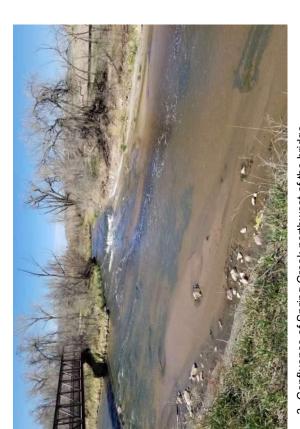
3. Confluence of Spring Creek northwest of the bridge.

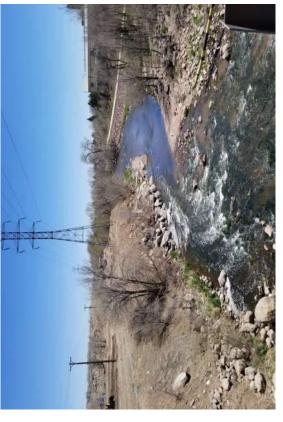
2. Downstream from the bridge.

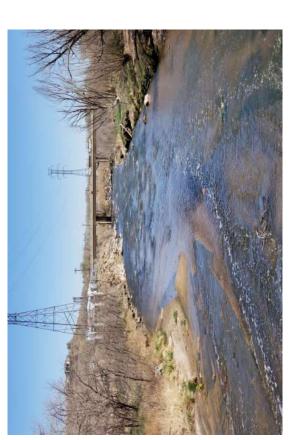
5. Janitell Bridge from upstream.

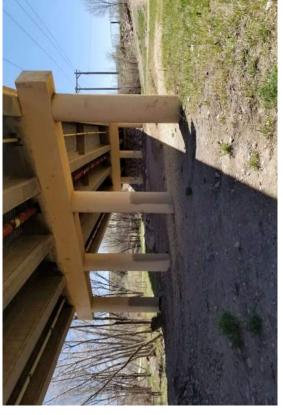
6. Gravel/sand bar, trail, and south abutment.
